COSSACK

DRAFT Conservation Management Plan
November 2017

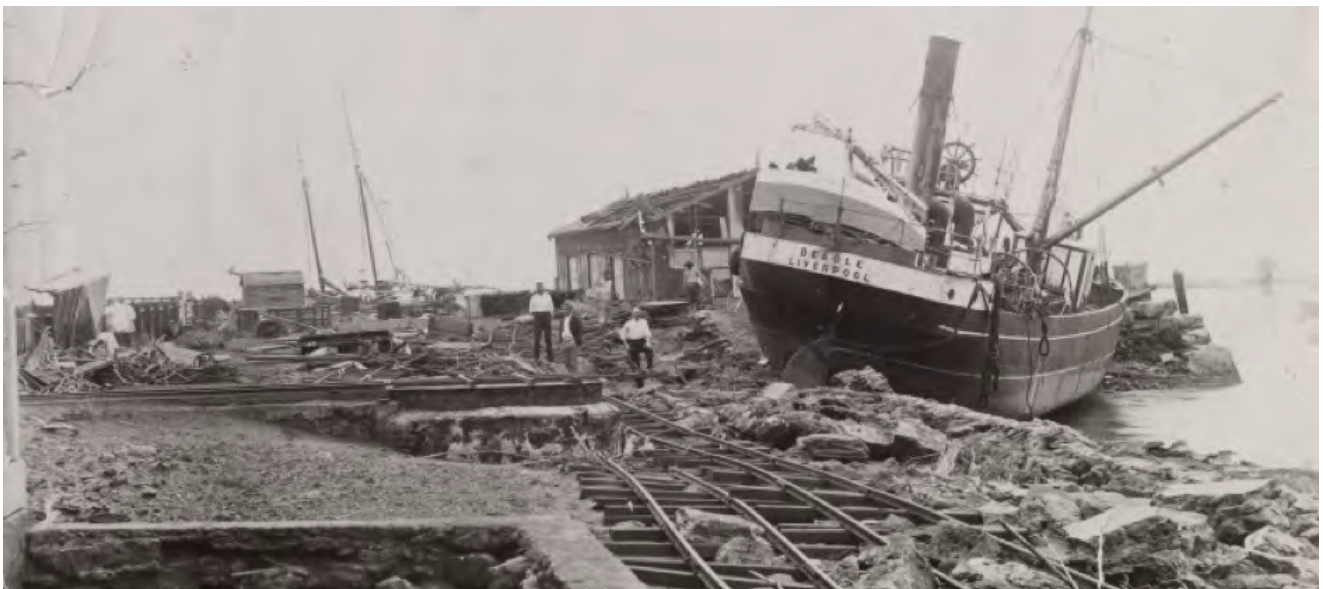
Figure 7. Cyclone damage at Cossack Wharf in 1898 (Source: State Library of Western Australia).

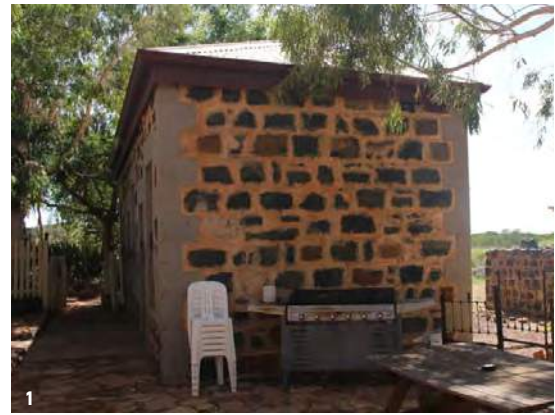
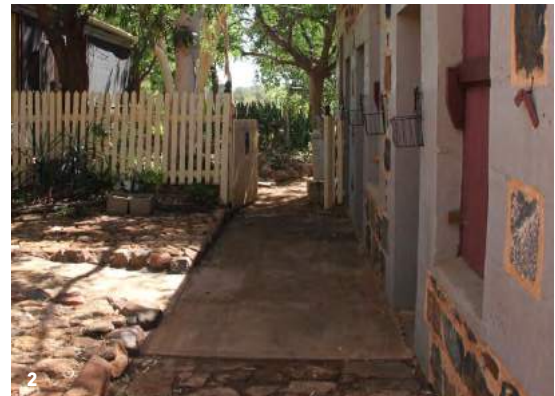
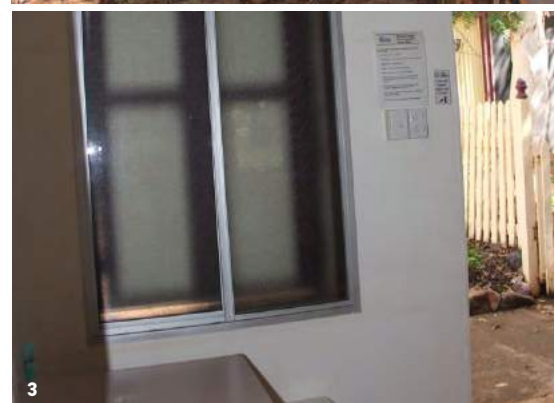
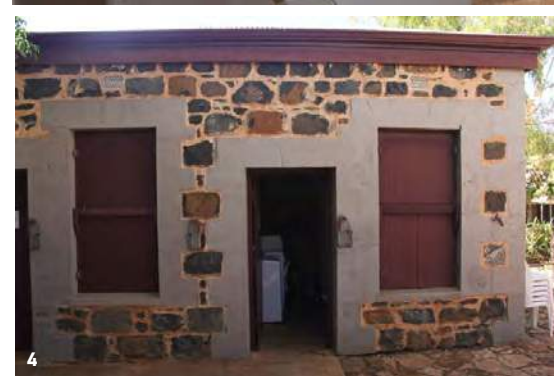
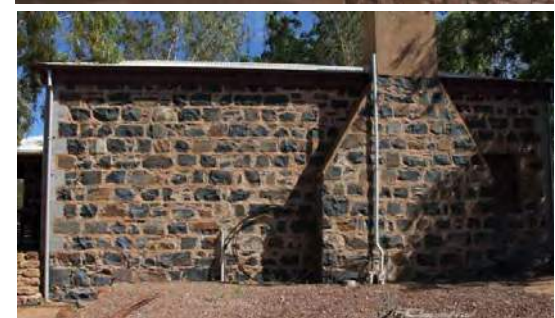
Condition	
<p>Generally, the place is in a fair condition. Areas that require attention include:</p> <ul style="list-style-type: none"> • Perform suggested maintenance works on Item 9 of CWS • Remove concrete floor front verandah, replace with limestone to match surroundings • Remove metal frame window from the bathroom, substitute for timber window, with glass panes, to match existing • Paint scrapes investigation to quoining, depending on existing integrity of cement render consider leaving it natural, otherwise paint with Bauwerk paint • Inspect and make good to rainwater system • All works to be performed accordingly to Section 11 of CWS <p><i>Note: Please refer to Conservation Works Schedule 2017</i></p>	
Photographs	
<ol style="list-style-type: none"> 1 View of southwest elevation looking northeast 2 Detail of floor composition 3 Detail of aluminum window frame and glazing 4 Detail of quoining on façade and timber panel windows 5 View of mortar composition of southeast elevation

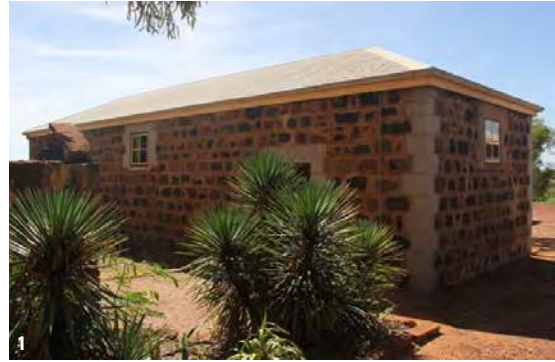
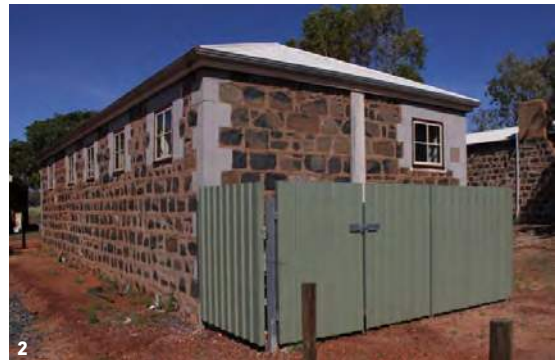
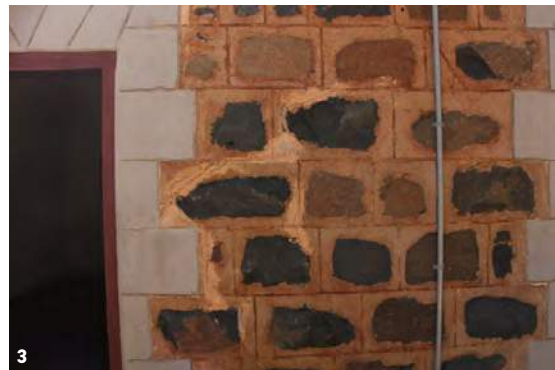
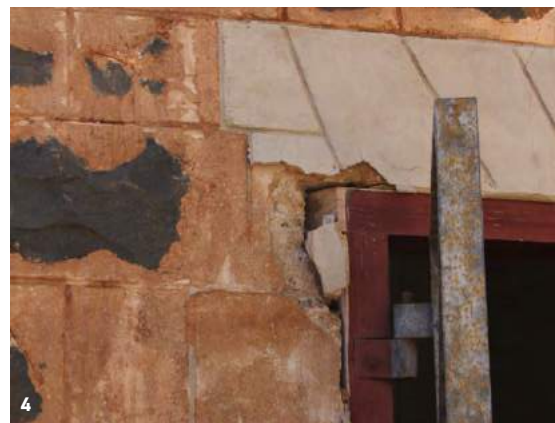
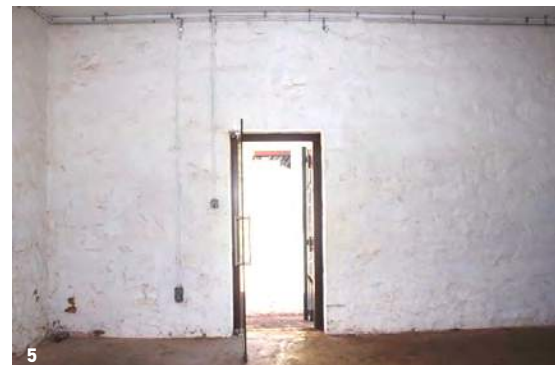
Photographs	
<ol style="list-style-type: none"> 1 View of northwest elevation looking southeast 2 Existing custom orb fencing to northeast elevation 3 Detail of quoining and mortar composition 4 Detail of timber frame and mortar composition to northwest elevation 5 Typical internal wall details

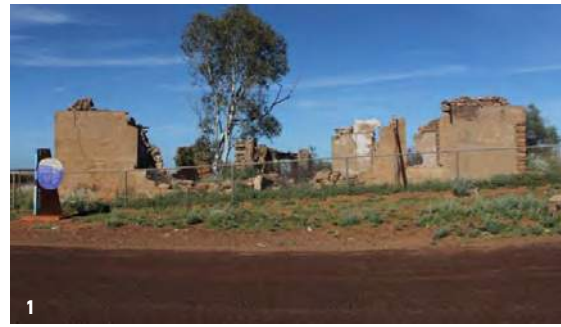
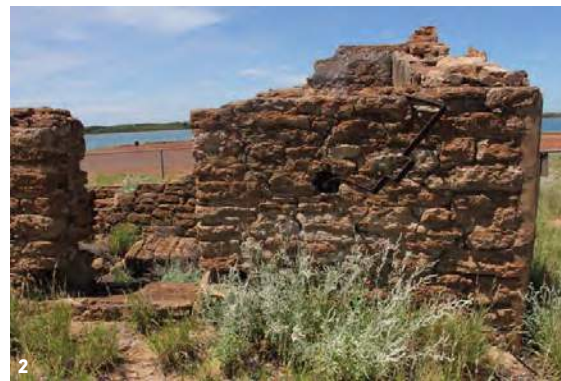
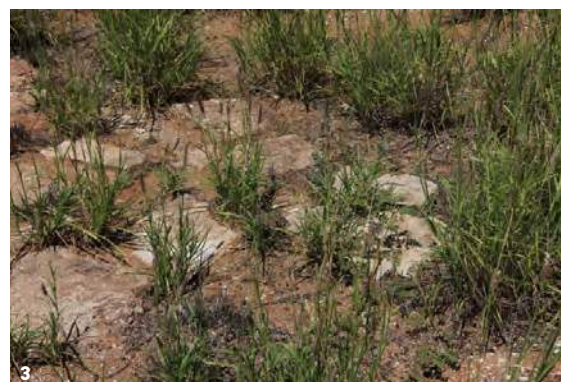
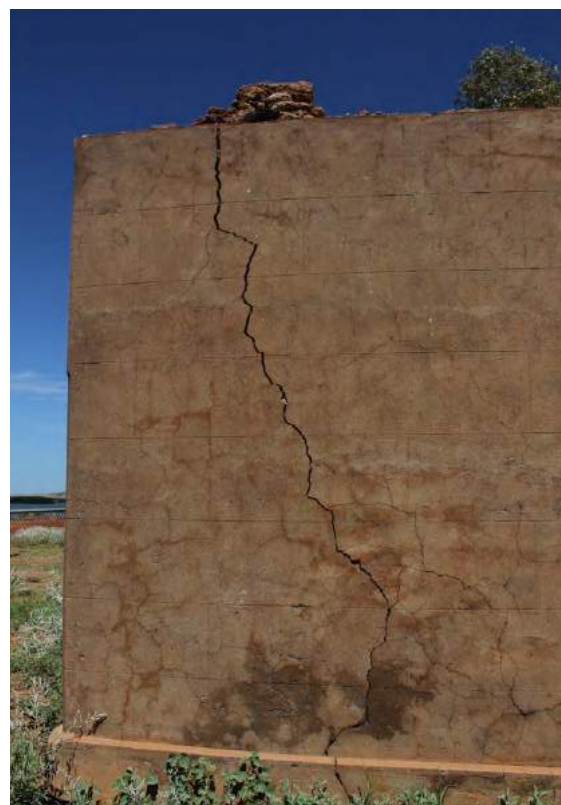
Photographs	
<ol style="list-style-type: none"> 1 View of remains looking southwest 2 Detail of steel remains within wall 3 Evidence of stone foundation remains 4 Detail of cracking to northeast elevation
