MASTER PLAN

KARRATHA CEMETERY

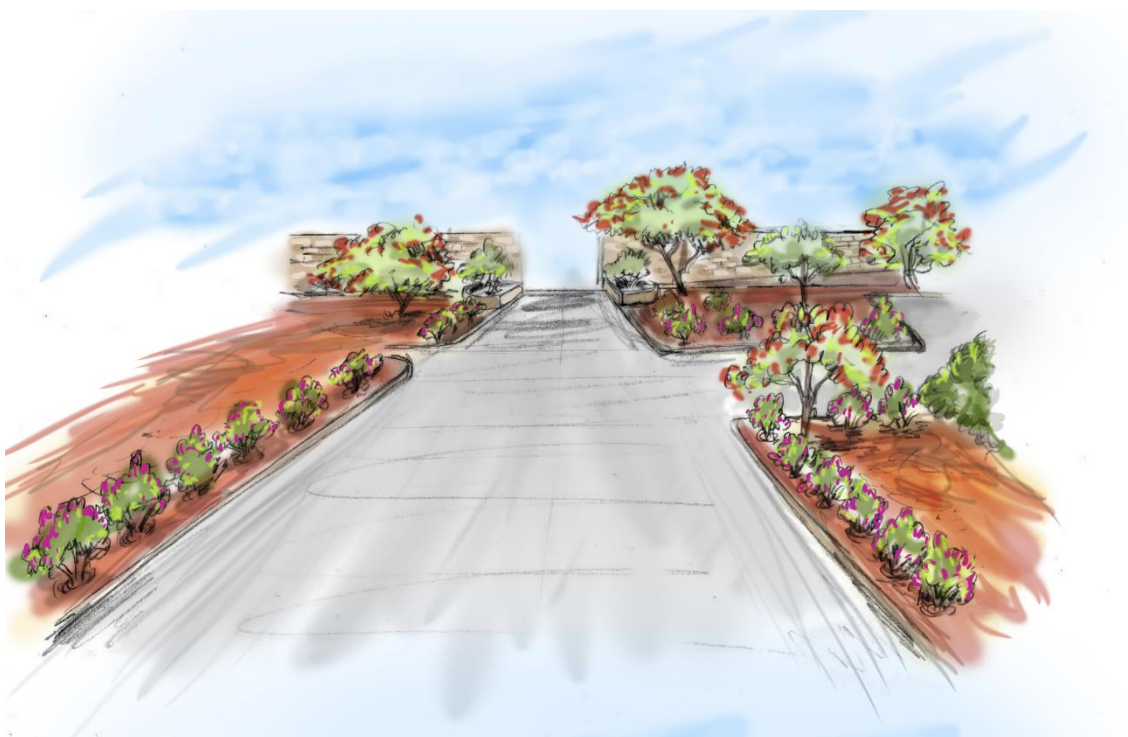
- Driveway/car park – the existing road surface and kerbing is in sound condition and does not require any maintenance, however the general amenity would be improved by regular road sweeping. Consultation with Waste Department confirms this will occur on a quarterly basis once the new street sweeping contract begins.
- Native vegetation plantation – mow/brush cut grass and remove deadwood and non native vegetation. Replant with eucalypt trees.
- Entrance
 - the existing gates are in sound condition however the paint is faded and should be sanded and repainted.

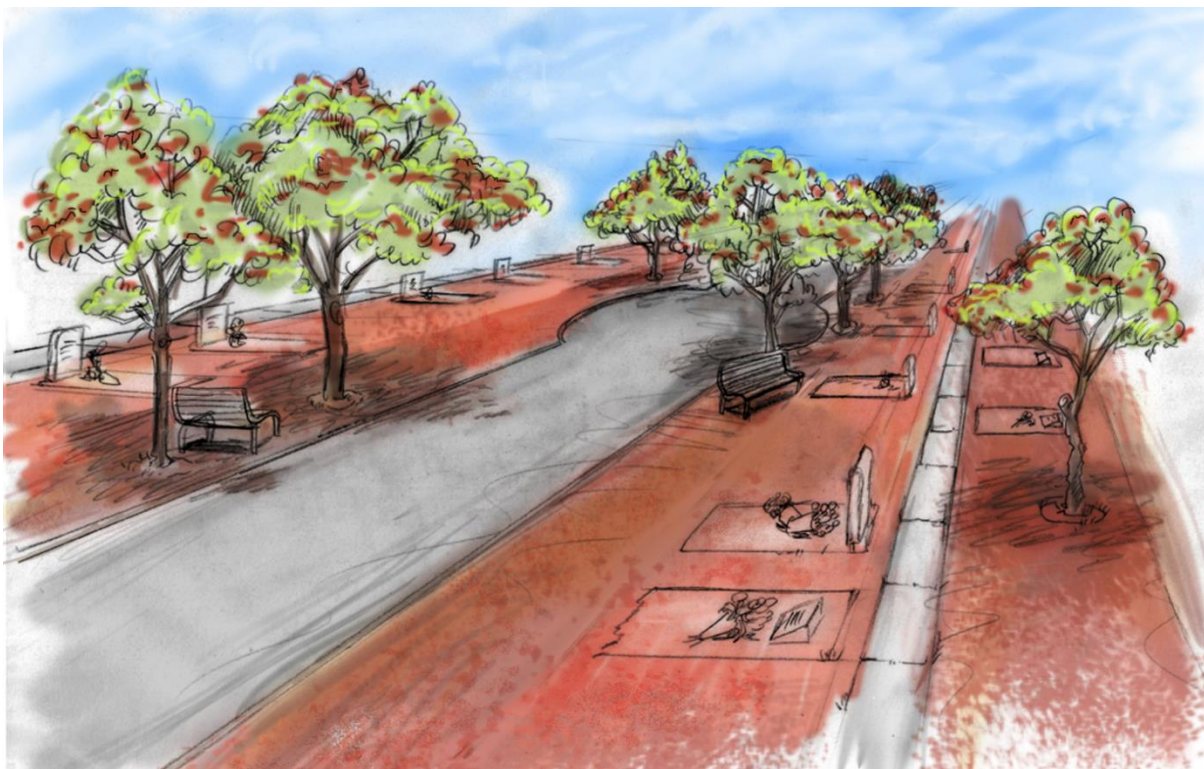
It is understood that the adornment of grave sites is an extremely personal and emotive issue, however the current overall impression of grave sites is one of neglect. Due to the extremely dry climate some sites have suffered compaction and require backfilling, some are adorned with weathered artificial flowers or other sentimental items.

Given limited water availability it is not possible to “turf” the grave sites, as would occur in more clement environments, therefore a material ie: gravel mulch, could be used to provide a more uniform appearance to the grave sites and blend in with the surrounding landscape.

To implement this suggestion would be quite expensive and could prove to be contentious as it would involve the removal of all artefacts (except headstones) levelling of the grave site area and covering with gravel mulch. To retain the gravel mulch within each section semi mountable kerbing would need to be laid.
