Roebourne Gaol Feasibility Study

This feasibility study has been commissioned by the City of Karratha to assess the viability of conservation and adaptive re-use options for the Roebourne Gaol buildings.

- B2: 1887 Cell Block
- B3: 1887 Kitchen Building
- B4: 1887 Police Quarters
- B5: the smaller 1896 Cell Block
- B6: the larger 1896 Cell Block
- B10: 1896 Gaoler's Quarters

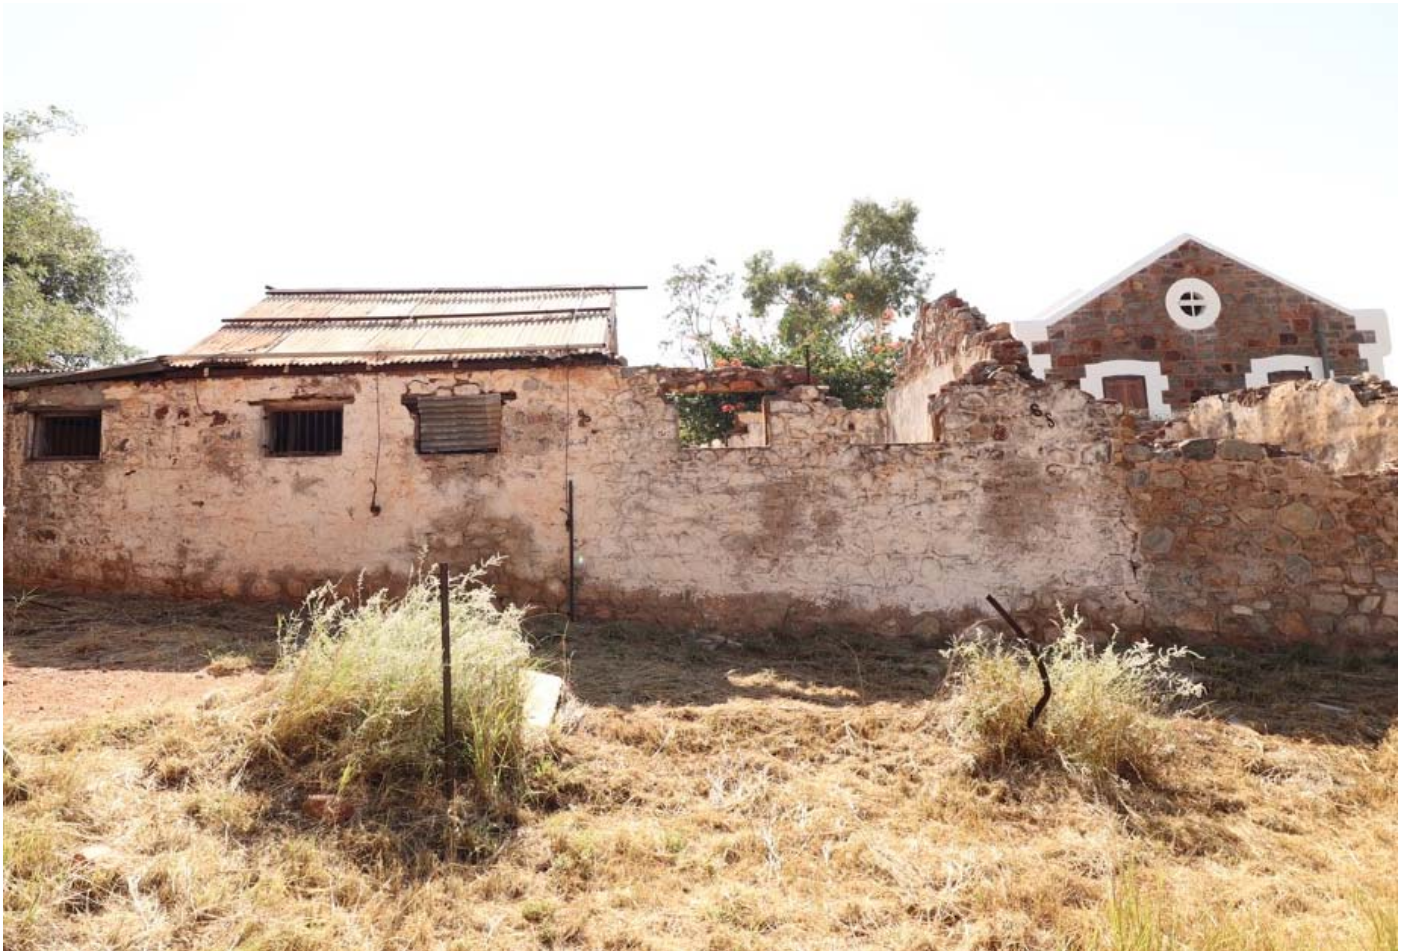
Figure 10: South east elevation of 1887 Cells

The original Cell Block was a simple structure comprising a range of four cells. The two western cells are set on higher ground with a floor level 290mm above the remaining two. Although the building is in a ruinous state, the original design intent of the place remains clearly discernible.

Today, the two easternmost cells are in a ruinous condition. The cells no longer have a roof and the top section of the stone walls has eroded. The walls have eroded to below window sill height in the south east cell and to lintel level in the adjoining cell.

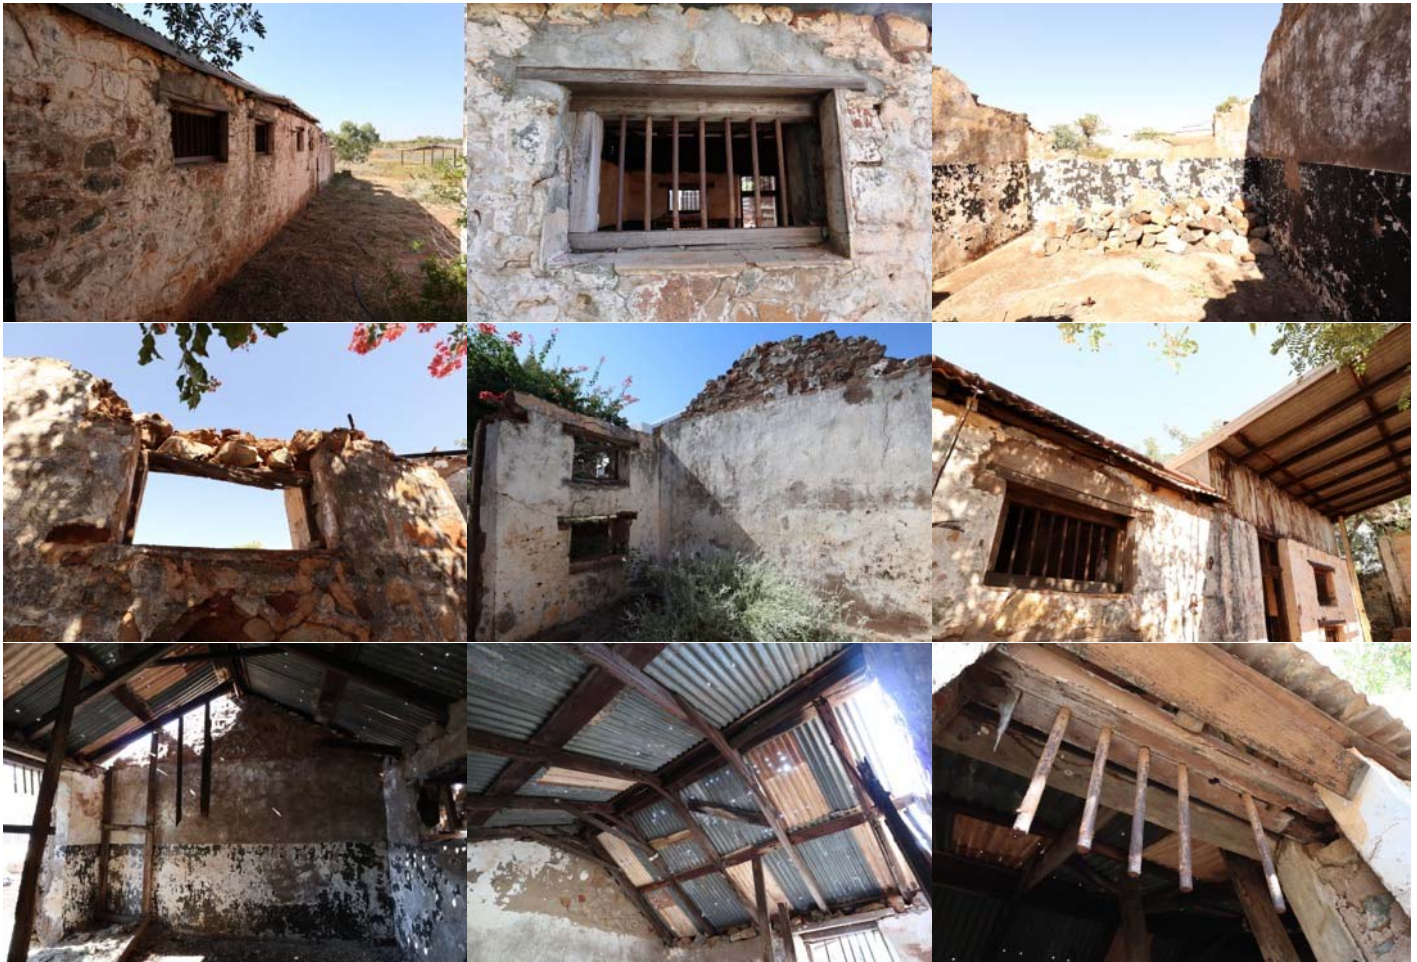
Figure 11: 1887 Cells

The cells at the western end are in a better condition being covered by roofing and all openings have been retained although the timber door and window frames have predominantly been lost. The roof above the western cell has been altered to incorporate a skillion roof which has been raised and extended across the walkway and adjoins a timber framed addition to the Kitchen/Day Room whilst the cell in between retains its original roof structure. The original roof structure is gable in form, which is open to the underside as the cells did not have ceilings. The corrugated iron cladding is patched and full of holes.

Original Function:	Cells
Current Function:	Unused
Condition:	Poor – ruinous at the eastern end, salvageable at the western end
Integrity:	The cell block would not be used as cell accommodation again but the place demonstrates high integrity in that it has become a ruin.
Authenticity:	The structure demonstrates a high degree of authenticity. A high degree of original fabric has been retained, albeit in various states of condition. The western end of the range has been adapted for alternative use but the original design intent of the cells still remains evident.

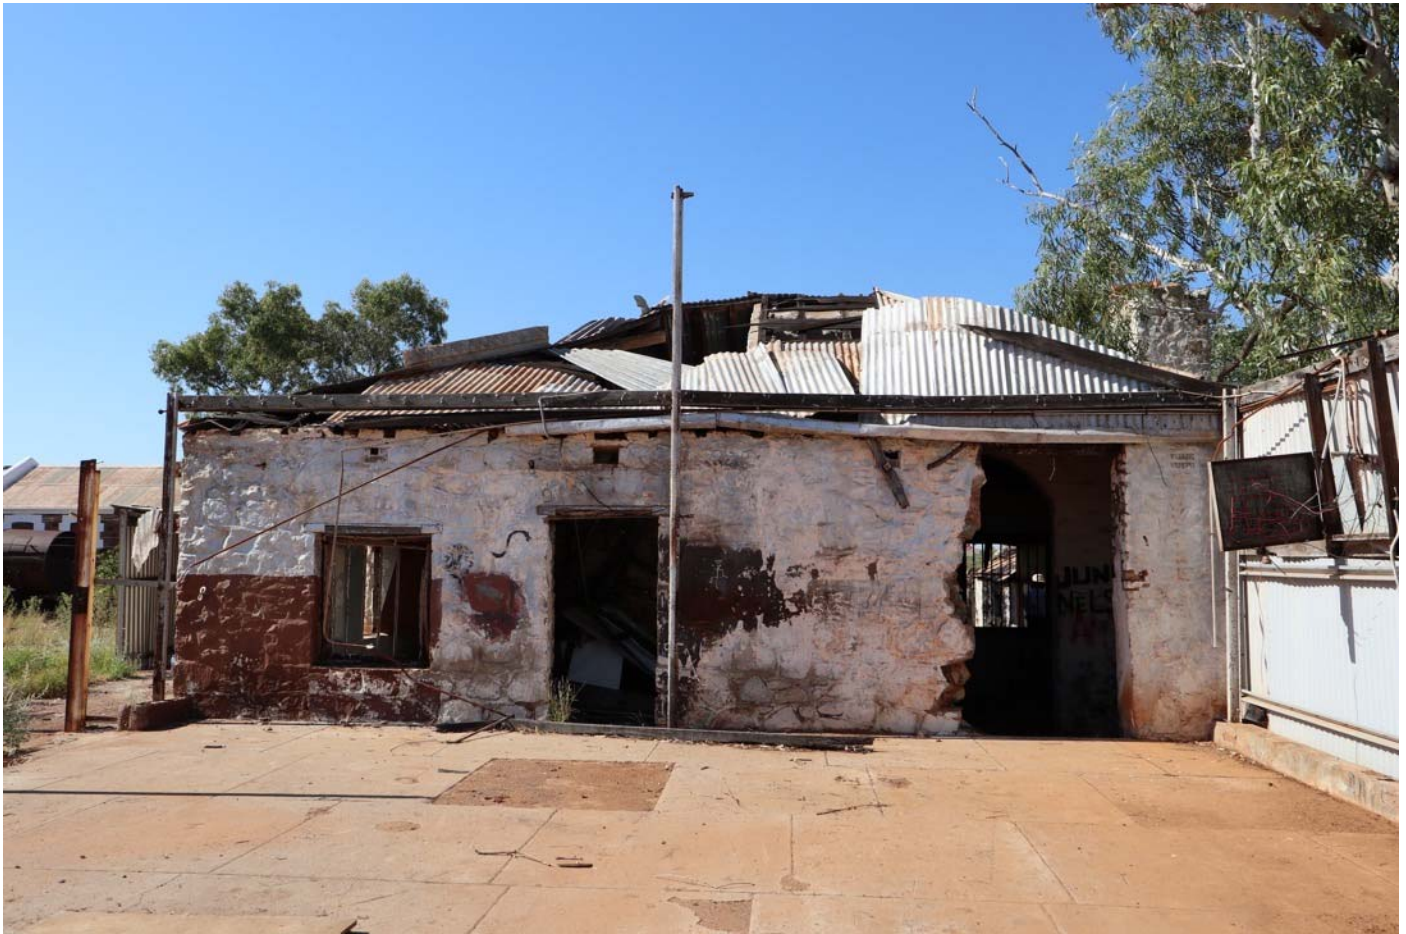
Figure 12: North east elevation of Kitchen and Day Room Building

The Kitchen/Day Room block is a stone walled building with a timber framed corrugated iron clad hipped roof. Timber framed additions have been constructed to the rear.

A corrugated iron roof structure links the lean-to on the east side of the Kitchen/Day Room block to the western most cell of the 1887 Cell Block. The motor repair business referred to above operated from here sometime before 1941. This business operated from the Kitchen/Day Room and the end cell of the 1887 Cell Block.

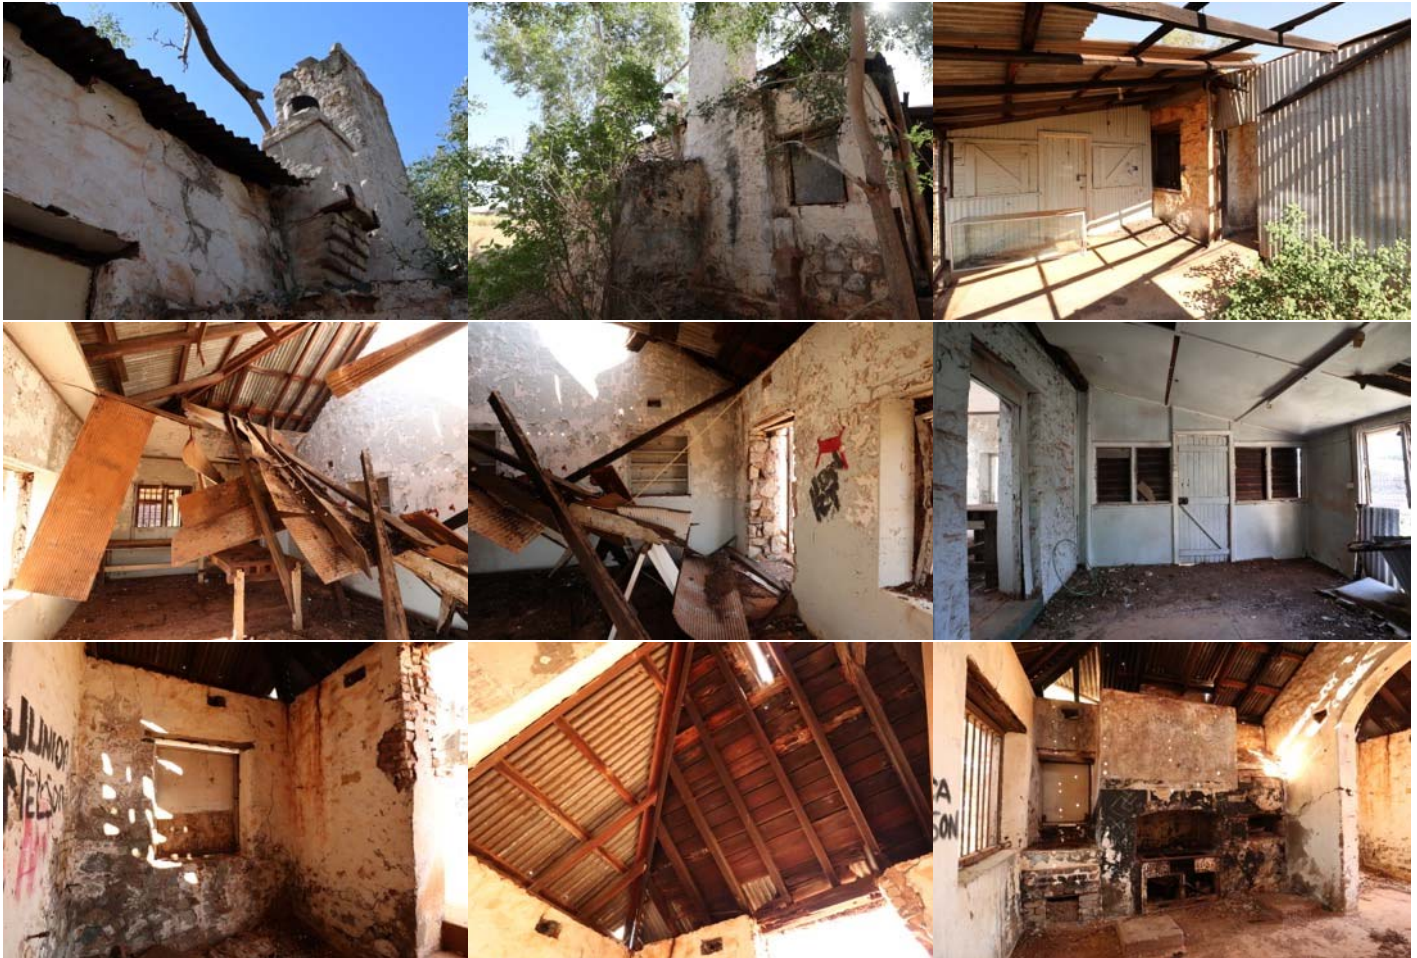
Figure 13: Kitchen and Day Room Building

In 1955 a corrugated iron structure with a vaulted corrugated roof, supported on large timber trusses, was added to the Kitchen/Day Room to serve as a workshop. This has been removed with only an extensive concrete slab remaining.

Condition:	Externally the walls are in fair and salvageable condition. The roof to the Day Room has partially collapsed and requires complete replacement. Graffiti on the kitchen walls. Loss of windows and doors, and associated joinery.
Integrity:	The place would not be used as a functioning kitchen again but due to its retention of fabric and kitchen installations, can be retained as an interpretative element. The Day Room could be restored and used as visitor facilities or other temporary use.
Authenticity:	The Kitchen and Day Room demonstrate a high degree of authenticity. Much original fabric has been retained, albeit in various states of condition. The additions can be removed.

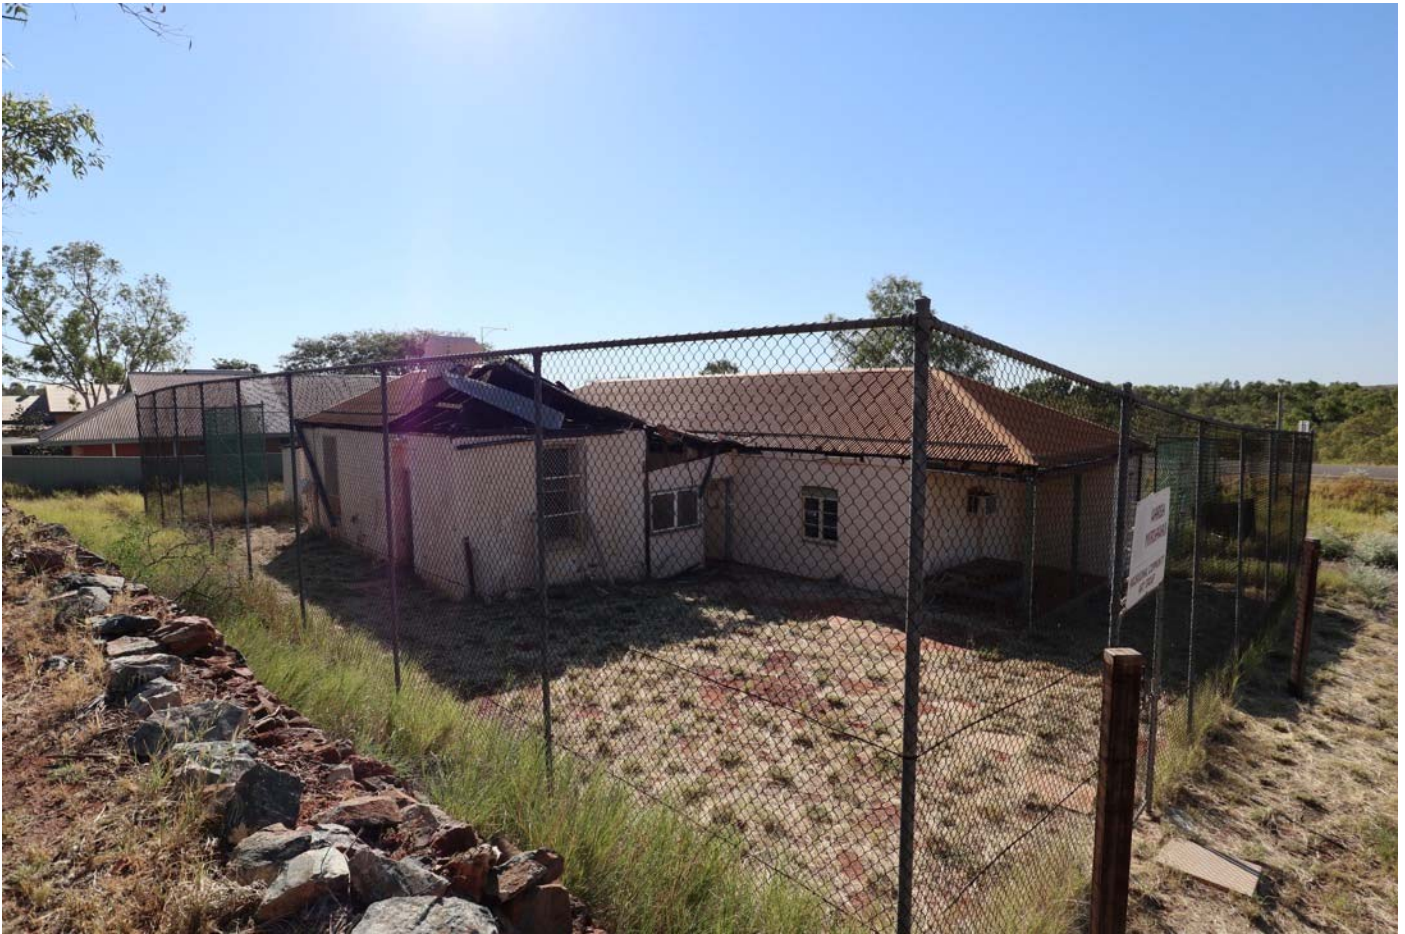
Figure 14: fmr Police Quarters

The 1887 plan shows the larger Quarters section and a separate kitchen block containing two kitchens to the west of the main building. The two sections have now been joined by an enclosed breezeway. The kitchen floors are at a higher level than those of the Quarters due to the slope of the ground, accessed by three concrete steps.

The Quarters originally comprised a lineal range of four rooms. The dividing wall between the two southern rooms has been removed to make a larger room.

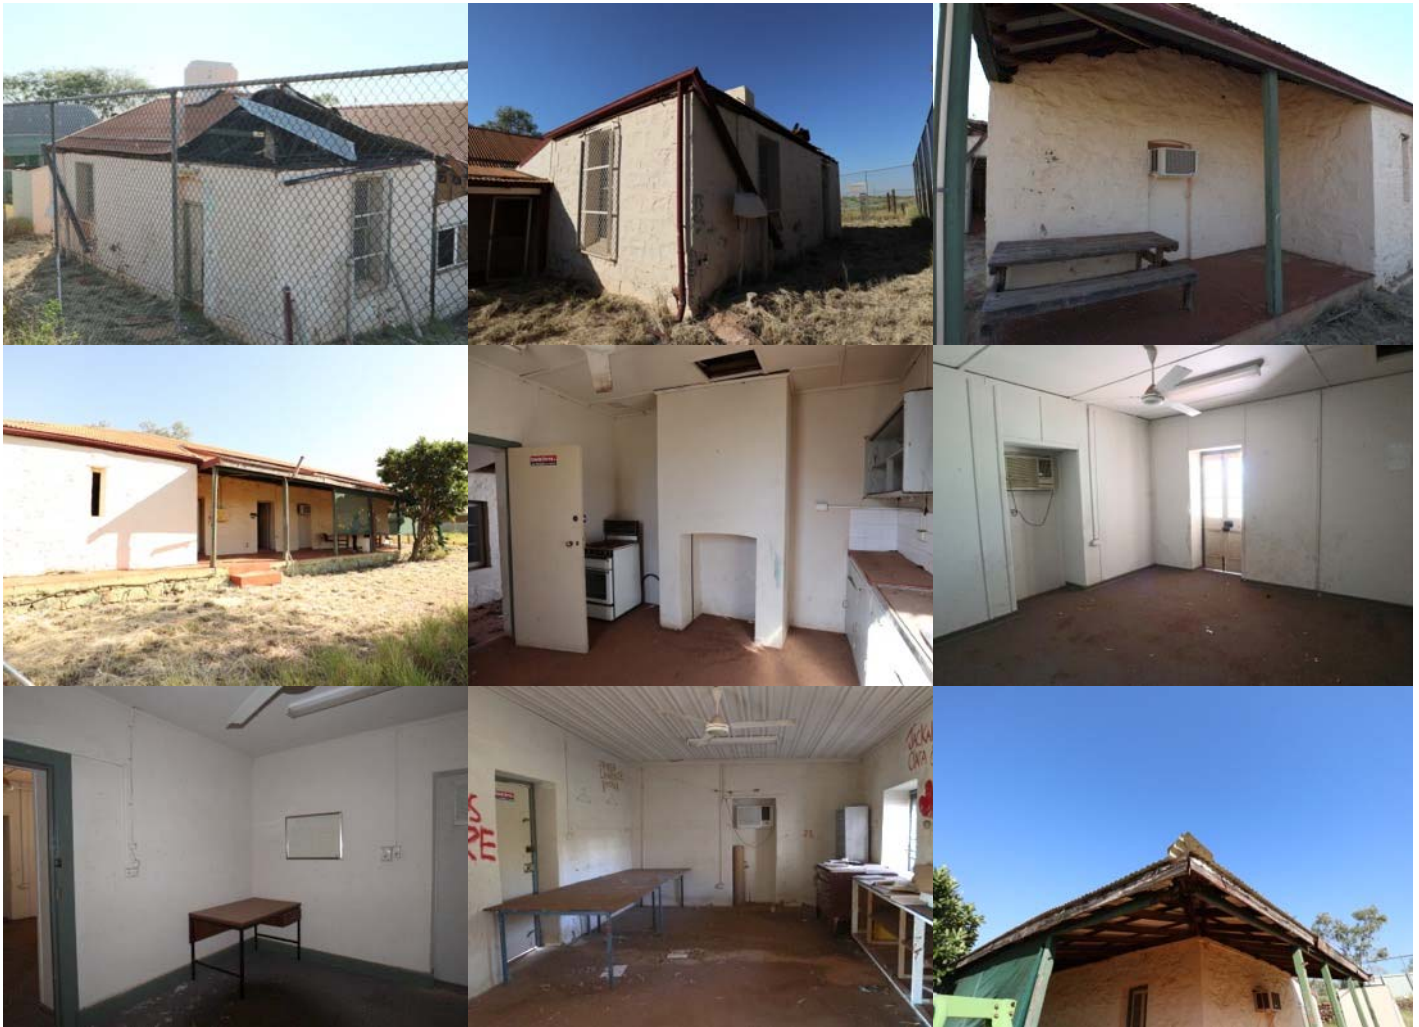
Figure 15: fmr Police Quarters

The northern most room has lined stud framed walls concealing the original stone walls, a battened ceiling and a timber floor. Ceiling mounted strip lights and fans have been installed with surface mounted conduits leading to GPO's. The original timber and glazed door on the east side of the room remains extant. The door on the west wall leading into the enclosed breezeway is not part of the original fabric as is indicated by the lack of rendered quoins which surround the original openings. The original external door in the north wall has been infilled and adapted to take an air conditioning unit. A non-original interconnecting door between this room and the adjoining Quarter's room has been installed.

The next room to the south has a painted concrete floor, a plaster finish on the walls and a suspended ceiling. The sashes of the window in the west wall opening onto the vestibule are side hung casements. The door in the east wall leading onto the verandah has been blocked in and accommodates an air conditioning unit.

The two rooms at the south end of the building as originally built have been knocked into one room with the removal of the dividing wall. The original window opening in the west wall has been converted to door access from the covered breezeway. The original timber and glass panelled door on the east wall has been replaced by a flush panel timber door. The south east door has been blocked up and a non-original opening in the south wall has been blocked up with an air conditioning unit being housed in this non-original opening. The room has plaster finish on the walls, the floor is concrete and ceiling is of a metal sheet 'Trimdeck' profile with surface mounted strip lights and fan.

Condition: The condition of the building is generally sound though somewhat run down in regard to paint finishes, internally and externally.

The southernmost of the kitchen and laundry has a sizeable crack near the doorway in the western external wall and cracks above the window in the southern wall. The timber sashes to this window have been replaced with adjustable louvers and the frame has extensive termite damage. The northernmost kitchen window has also suffered termite damage and the sill has been raised to accommodate a kitchen bench.

The concrete verandahs are cracked and in places the surfaces are crumbling. The flywire to the enclosure of the south verandah requires removal or replacement.

The roof in places has been damaged in the 2015 cyclone.

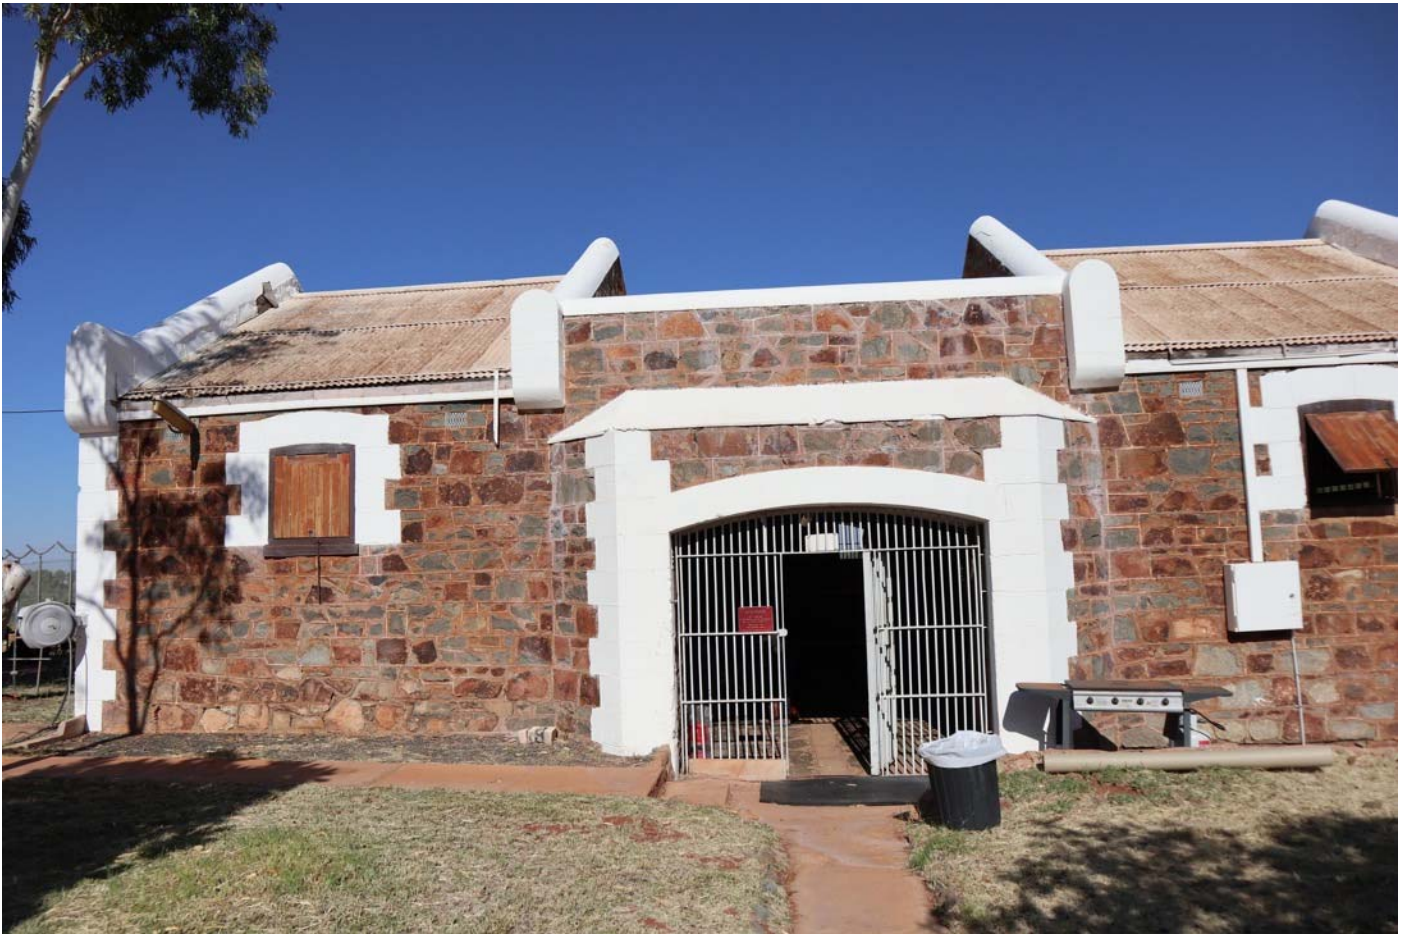
Figure 16: North west elevation of smaller 1896 Cell Block

The small cell block is planned on similar lines as the large block, though with four smaller cells arranged in pairs. As with the main cell block and other buildings on site, the smaller cell block is of stone construction with concrete quoining around the openings and at the edges of the walls. The only entrance into the building is located on the north west elevation in a projecting porch, with gridded opening.

The four cells are arranged in pairs and are separated by a rectangular exercise yard which was initially open but has since been enclosed during the occupancy of the Vacuum Oil Company which occurred from the closure of the Gaol until the lease was terminated in the 1950s. The exercise yard roof is corrugated iron clad skillion falling from west to east and supported on a framework of large sawn timbers marked "V O Co Port Sampson" (Vacuum Oil Company).

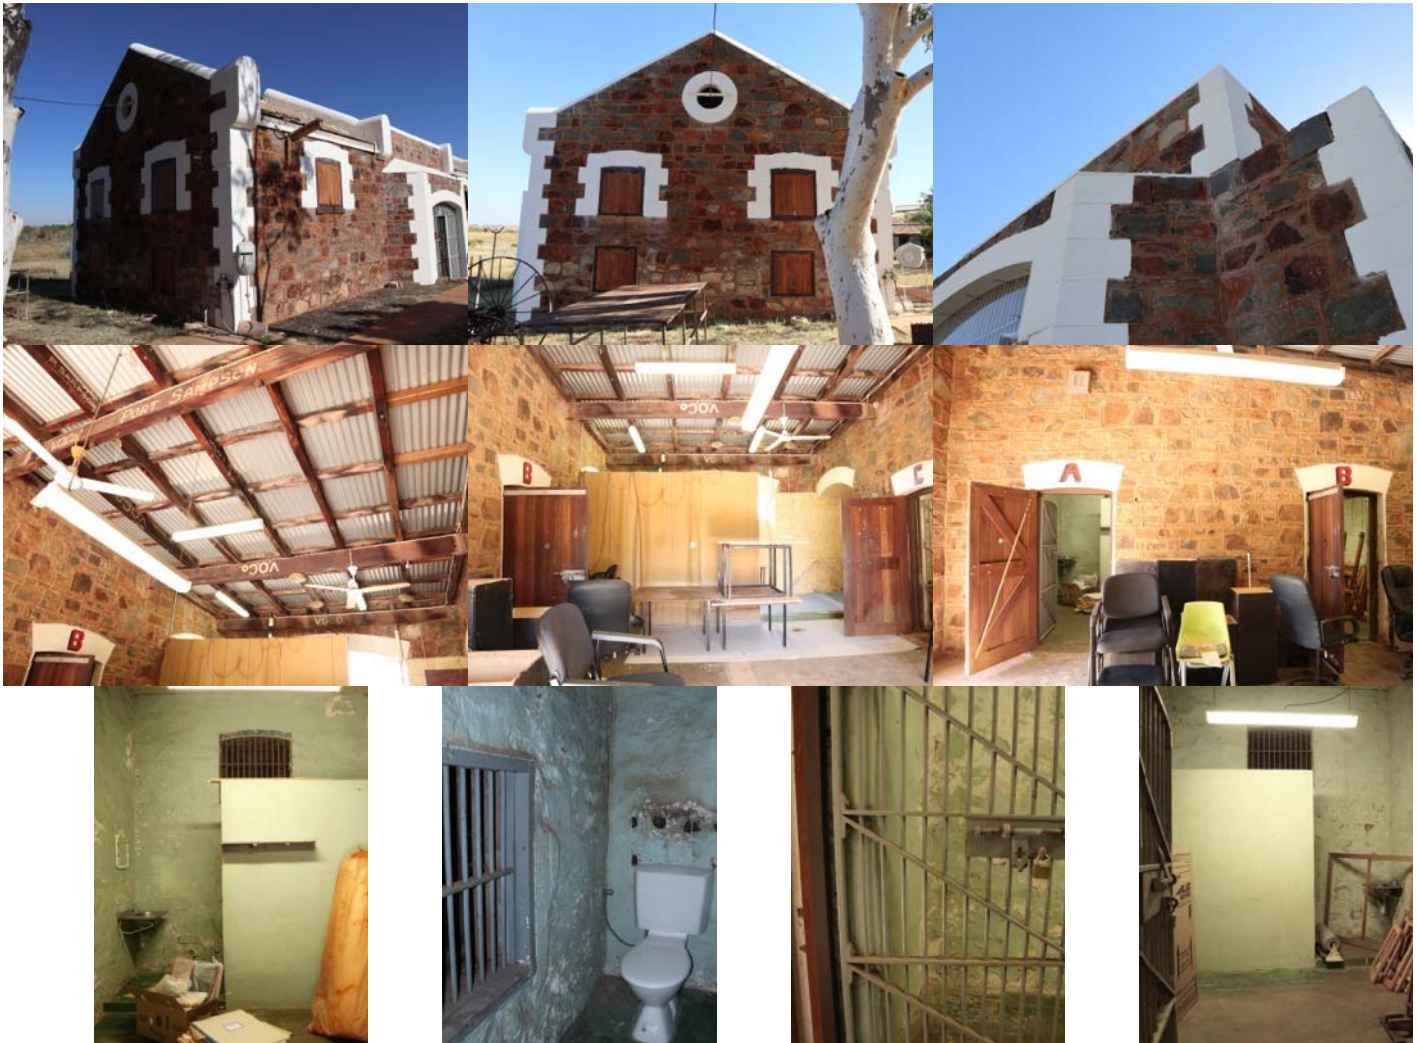
Figure 17: smaller 1896 Cell Block

The walls to the exercise yard are fair faced stone although the wall to the eastern end where the showers are located has been painted over. The concrete arches over the openings and the cement rendered architraves to the doors are painted white.

At the east end of the exercise yard is an alcove which originally housed latrines and a urinal. This was subsequently upgraded to include a shower, wash troughs and toilets prior to the reopening of the gaol in the 1970s. The toilets have been removed and the wash troughs replaced with metal sinks. This section of the cell block is screened by a timber stud partition.

Condition:	Fair
Integrity:	The cell block demonstrates a high degree of integrity. Although the space will not be used to incarcerate prisoners the internal planning remains extant and easy to understand, providing an interpretation of its original function.
Authenticity:	The cell blocks demonstrates high authenticity with much of the original fabric remaining extant. Alterations have been made but for the most part, these have had limited impact on original fabric and presentation.

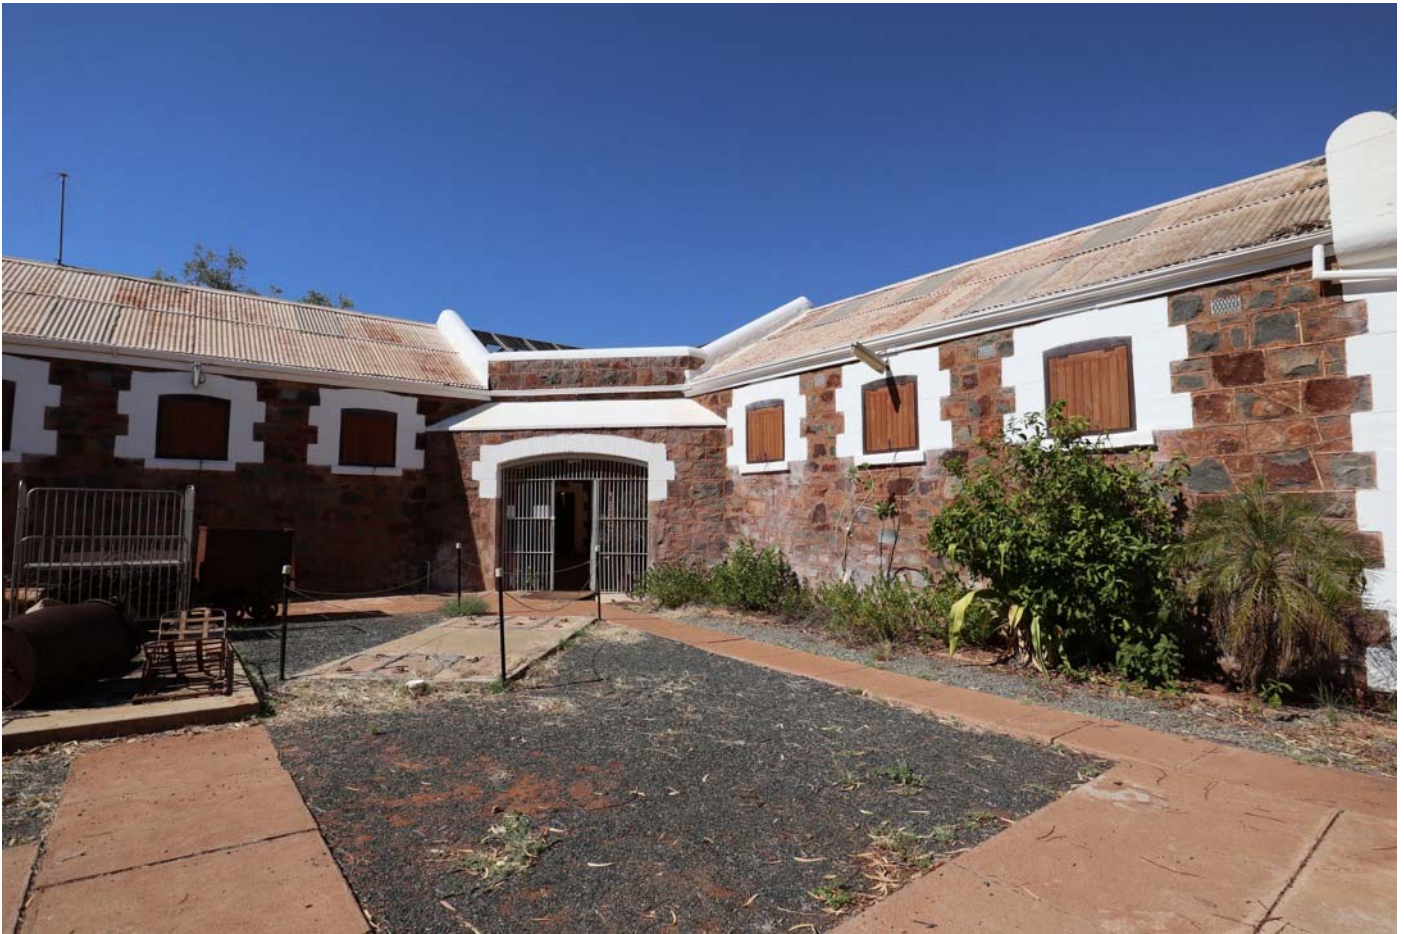
Figure 18: Larger 1896 Cell Block

The larger cell block is made up of four wings radiating from a central exercise yard. The wings are interconnected on the external face by diagonal stone walling creating the distinctive octagonal shape to the internal exercise yard.

The walls built on the diagonal contain niches facing onto the exercise yard. One niche accommodated latrines, another contained an entrance which was originally 1200mm wide and subsequently enlarged. The walls are of fair faced stonework with a 1200mm black dado to all walls apart from the hand basin wall which was painted white to window sill height. The concrete quoins and heads of the openings are painted white. The arch over the east window has been painted black which is now wearing away.

The resulting octagonal enclosure was not roofed and served as the exercise yard. This yard was roofed over with an open grid of steel girders and mesh in 1979-1980 in order to stem a spate of escapes on the part of the prisoners who were given permission to sleep in the yard to avoid the heat in the cells.

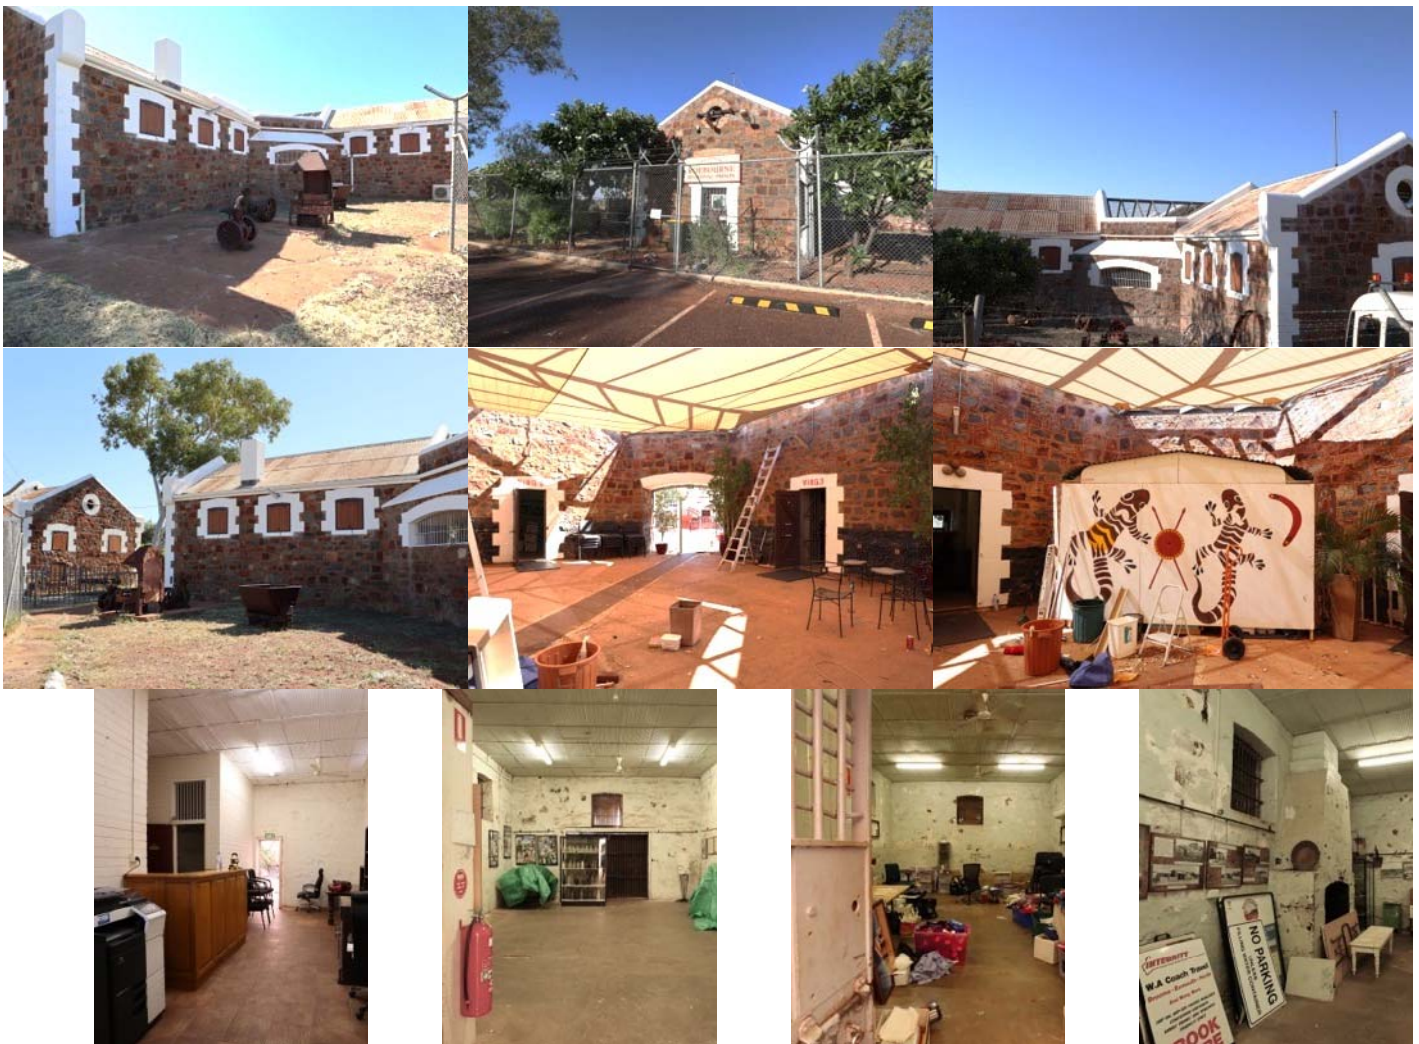
Figure 19: Larger 1896 Cell Block

Each wing is roofed with a gabled, timber framed, corrugated iron clad roof abutting the stone parapet walls at each end of each wing. The ceilings are of ripple iron, the internal walls of the wings are rendered and lime washed with the later applications of PVA paints. The longer walls of each wings have five evenly spaced manacle rings built in approximately 600mm above floor level. The windows are made secure with iron grilles and protected with timber storm shutters. The floors are of roughly laid concrete.

The timber doors connecting the wings of the cell block to the exercise yard have been replaced due to damage or termites. The timber storm shutters have also been replaced.

Condition: Fair

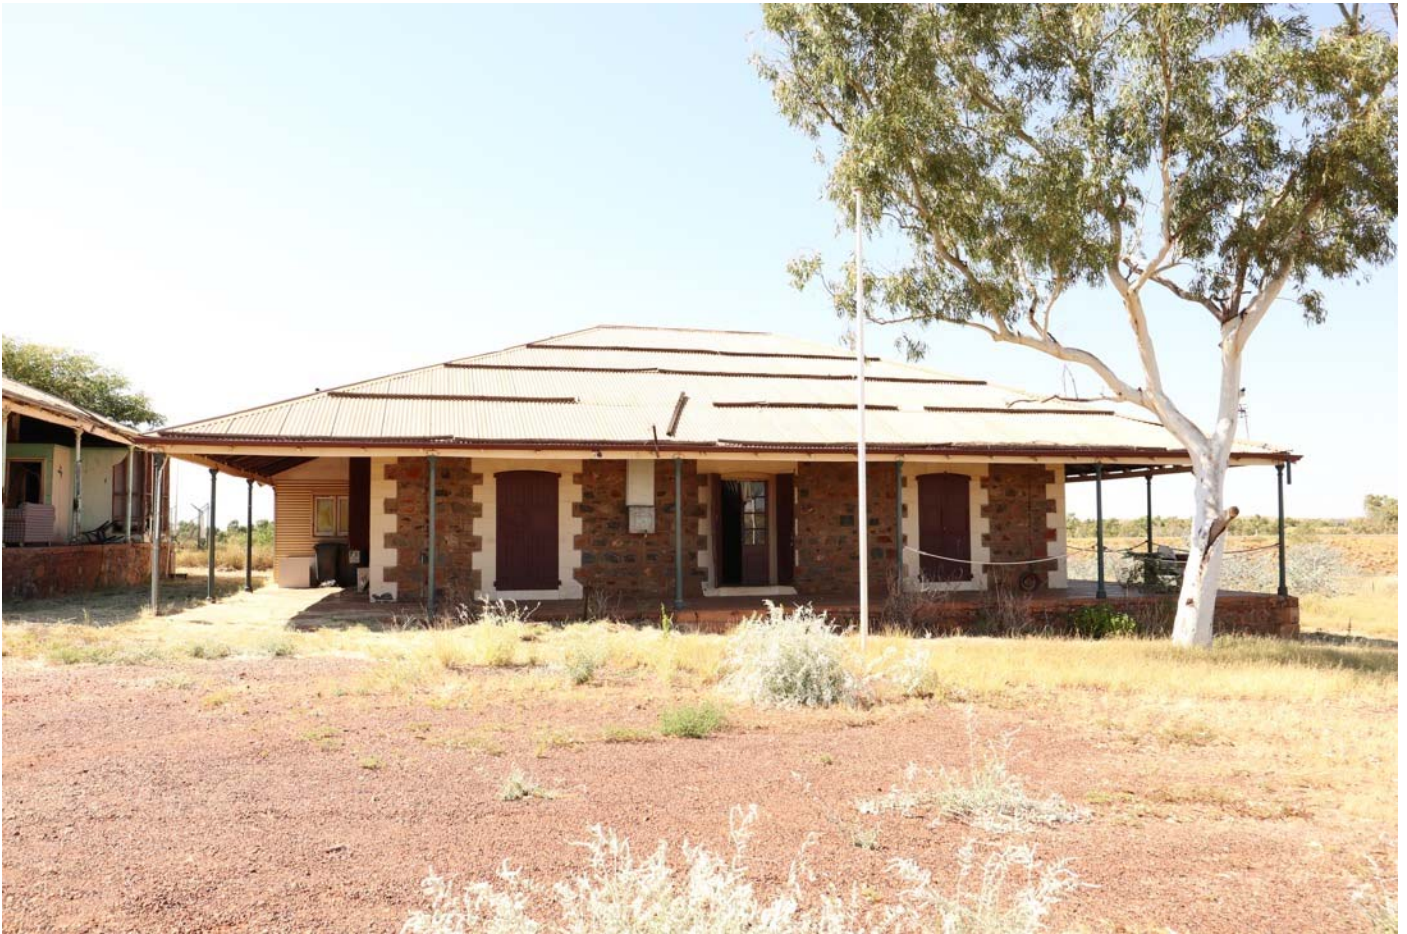
Figure 20: West elevation of Gaoler's Quarters

The Gaoler's Quarters is a simple stone building with hipped roof that continues down to form the deep verandah canopy. The front elevation of the premises turns it back on the main precinct and faces out across Hampton Street. The place is located at the south east corner of the precinct in with a more distant relationship with the remaining buildings on the site, with the exception of the Warder's Quarters immediately adjacent.

The roof is hipped, clad with short sheet corrugated iron and held down with storm battens. The south plane of the roof has been replaced with zincalume and does not incorporate the external storm battens.

The building is of fair faced stone construction with quoining to the openings and abutments of the elevations. Unlike the other buildings around the site of similar constructions, the Gaoler's Quarters also has an additional 450mm concrete lintel extending around the structure. No explanation of this feature has been found in any documentary evidence or on site during the physical assessment.

Condition:	Fair to good
------------	--------------
