COSSACK

DRAFT Conservation Management Plan
November 2017

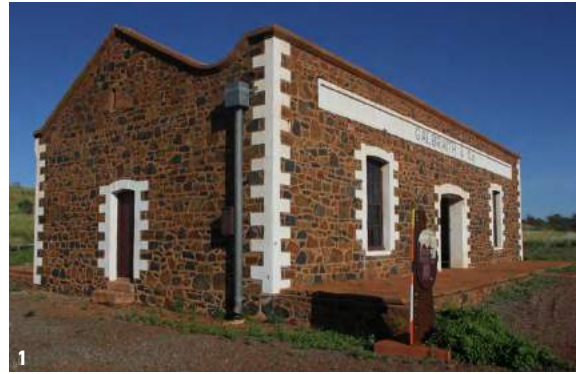
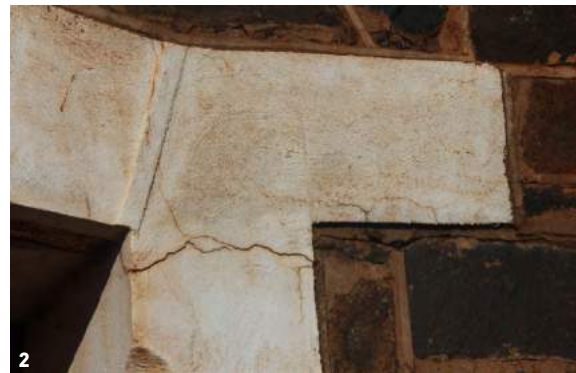
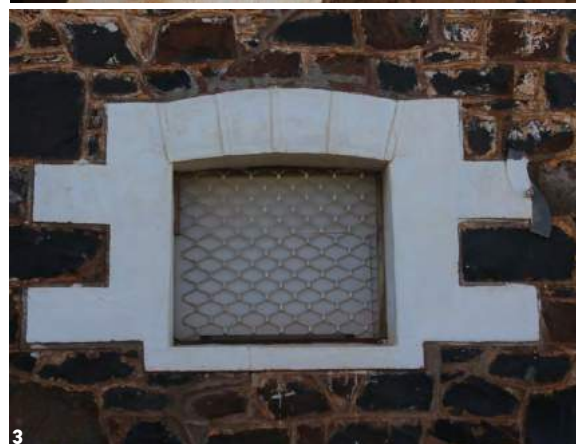
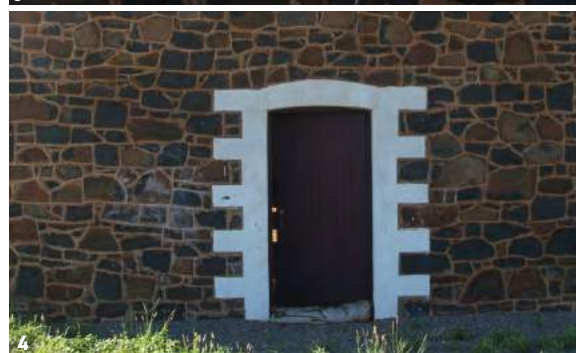
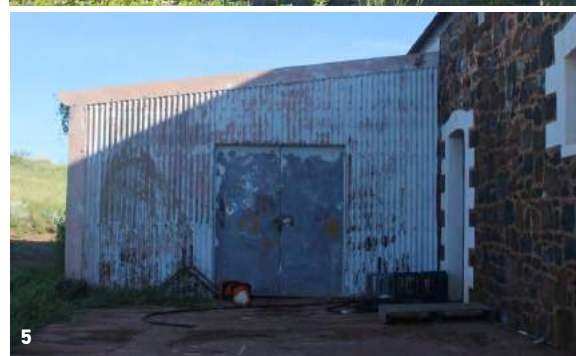
Galbraith's Store

There is evidence of cracking throughout the mortar on all walls of the building. The original roof of the building has since been replaced with corrugated metal sheeting, in keeping with the original. Attached to the eastern elevation is a small storage addition which is constructed of corrugated metal sheeting. The building has been erected over a stone foundation which has been levelled with the natural topography that slants slightly south. Rock rubble with bastard tuck pointing surrounds the building on the floor, which has been constructed over a stone foundation.

- 1 View looking northwest from Pearl Street
- 2 Detail of cracking and mortar composition to quoining
- 3 Detail of window to be reinstated
- 4 View of annex looking north to be rust treated and repainted
- 5 View of efflorescence to be treated throughout building

- Perform suggested maintenance works as per Item 9 of the CWS
- Remove all redundant electrical wires
- Test existent mortar composition and paint scrapes investigation on lean-to annexe and to quoining's
- Engage a heritage structural engineer for structural report before fixing major cracks
- Treat efflorescence accordingly to Item 11 of the CWS
- Manually rake out all cement pointing and repair with traditional mortar
- Reinstate windows as per CWS
- Paint scrapes investigation to quoining, depending on existing integrity of cement render consider leaving it natural, otherwise paint with Bauwerk paint
- Rust treat and paint lean-to annexe accordingly to paint scrapes result
- All works to be performed accordingly to Section 11 of CWS

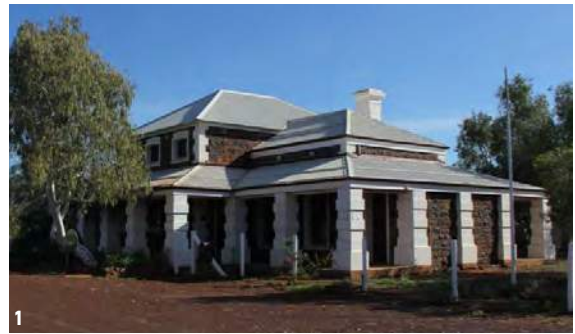
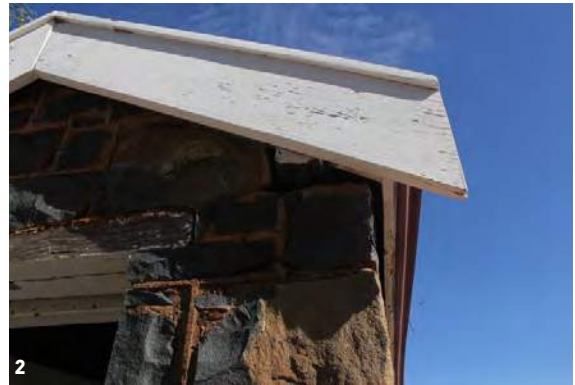
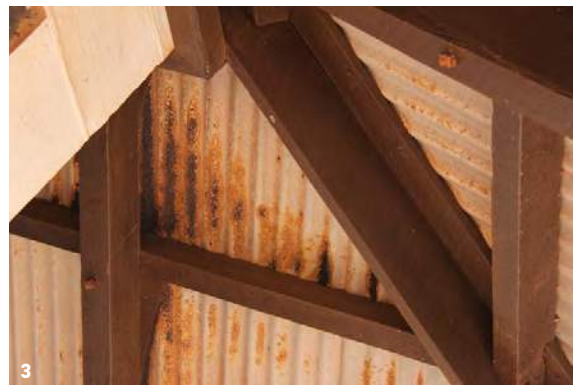
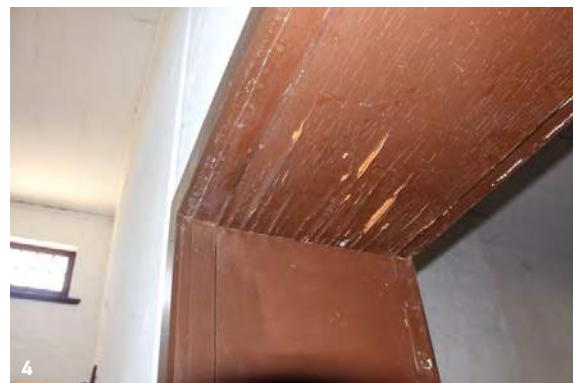
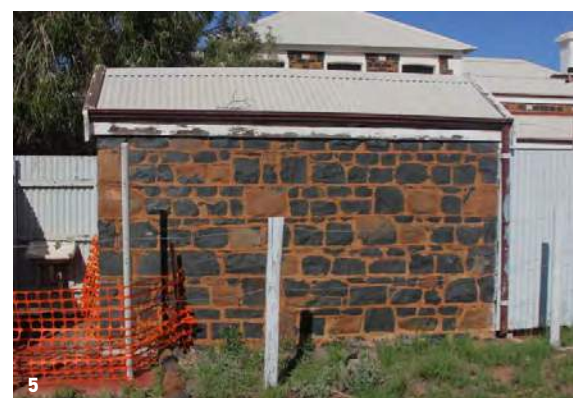
Photographs	
1 View looking northeast from Pearl Street 2 Detail of paintwork to fascia 3 Detail of rust to roof sheeting 4 Detail of pain work to internal timber door frame 5 View of brickwork to toilet

Floors	Concrete floors
Fixtures and Fittings	Various display cabinets, benches and internal fittings
Electrics	CCTV and florescent lighting
Others	Fireplace with timber mantle
Toilets	
Custom orb galvanised iron with timber fascia, bluestone wall, ledged and braced timber door to each toilet, no privacy latch, cement topping to verandah floor severely cracks at re-entrant angles, remnants of original cover remain	
Condition	
<p>Generally, the place is in a fair condition. Areas that require attention include:</p> <ul style="list-style-type: none"> • Perform suggested maintenance works on Item 9 of CWS • Remove all redundant electrical wires • Test existent mortar composition and investigate paint scrapes • Engage a heritage structural engineer for structural report before fixing major cracks • Manually rake out all cement pointing and repair with traditional mortar and limewash • Roof structure not inspected • Repair roof sheeting • Repair rainwater system • Repair all bargeboards, eaves and so its • Repair loose roof sheeting • Repair all metal ceilings, paint finish • Run new underground power supply, internal conduit vertical drops from ceiling, use galvanised metal conduit and industrial GPO's/switches. GPO's to be surface mounted galvanised boxes and face panels. All metal fittings to be earthed to code • Repair toilets and toilet roof structure • Repair joinery doors and windows • All works to be performed accordingly to Section 11 of CWS <p><i>Note: Please refer to Conservation Works Schedule 2017</i></p>

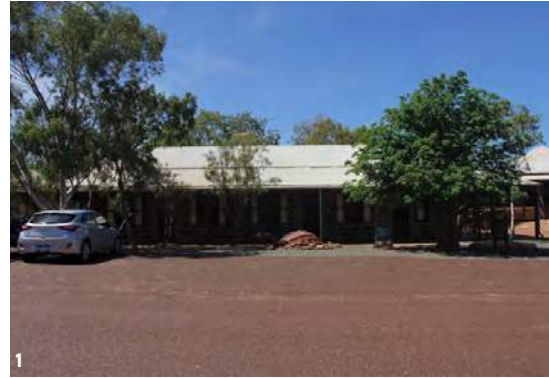
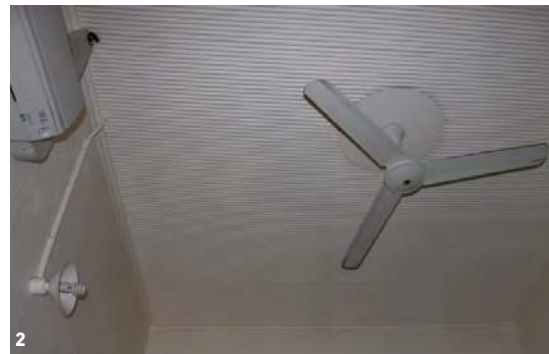
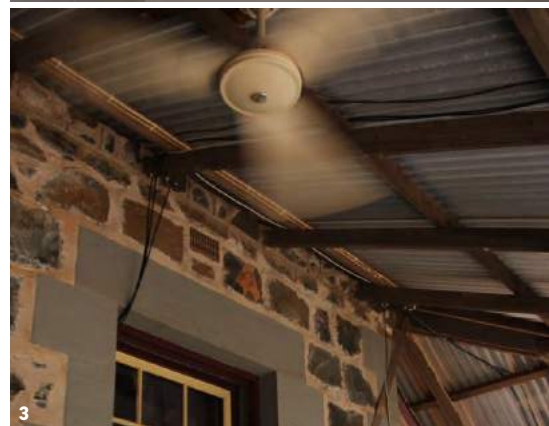
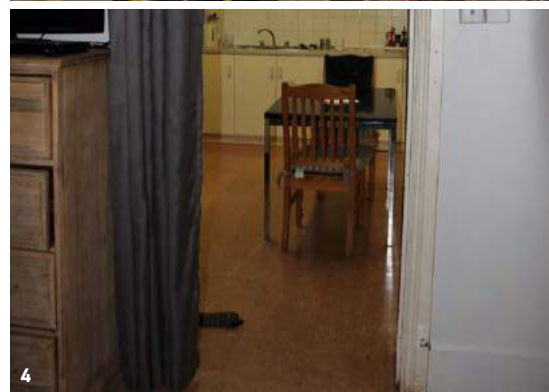
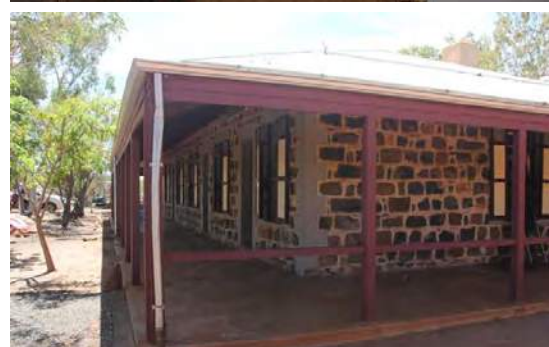
Photographs	
<p>1 View looking east from Pearl Street 2 Detail of internal ceiling fan and air-conditioning ducts 3 Detail of electrical cables 4 Detail of vinyl floor 5 View of verandah and downpipe</p>

Others	Concrete chimney
Internal	
Ceiling/Roof	Ripple iron ceiling
Walls	Gloss paint finish, rendered wall, timber rail to wall
Openings	Timber French glazed windows and paneled timber windows. Three paneled timber door
Floors	Vinyl floor
Fixtures and Fittings	Sink, bench top with cupboards under, cupboards over and stove
Electrics	Two hanging florescent tubes on chains, ceiling ran and power points, air conditioning, light and GPO's
Others	Fireplace with timber mantle
Condition	
<p>Generally, the place is in a fair condition. Areas that require attention include:</p> <ul style="list-style-type: none"> • Perform suggested maintenance works on Item 9 of CWS • Run new underground power supply, internal conduit vertical drops from ceiling, use galvanised metal conduit and industrial GPO's/switches. GPO's to be surface mounted galvanised boxes and face panels. All metal fittings to be earthed to code • Inspect what is under vinyl floors, and depending on the integrity of existing floor below it leave original floor exposed (eg. concrete floor), make good • Paint scrapes investigation to quoining, depending on existing integrity of cement render consider leaving it natural, otherwise paint with Bauwerk paint • Inspect roof structure and repair accordingly to section Recommended Building Works of this report • Reinstate 02 doors to room 11 and 4 to match existing timber panelled doors • All works to be performed accordingly to Section 11 of CWS <p><i>Note: Please refer to Conservation Works Schedule 2017</i></p>

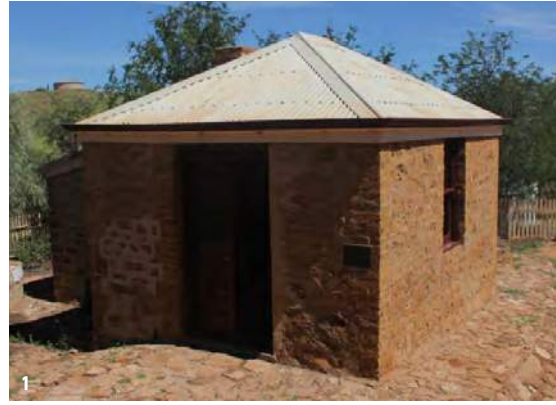
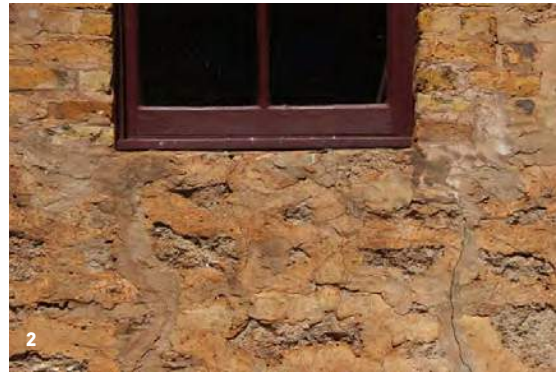
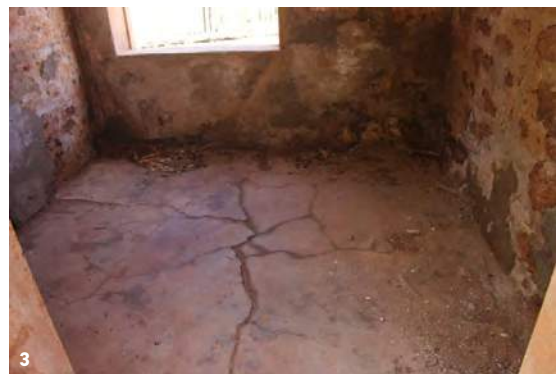
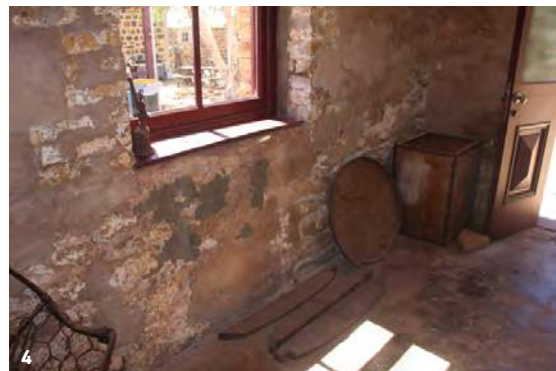
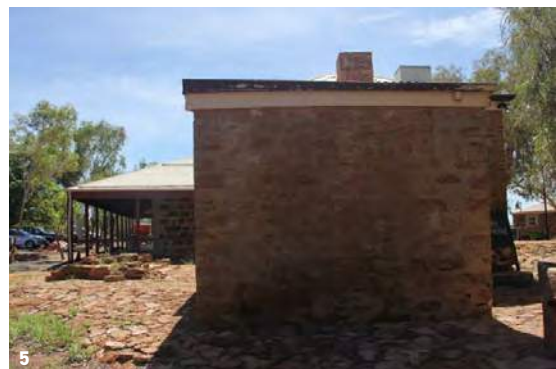
Photographs	
<p>1 View of southwest elevation looking northeast from Pearl Street 2 Detail of mortar composition 3 Detail of floor composition 4 Detail of mortar composition and timber window frame 5 View of northwestern elevation</p>

<i>The Bakehouse</i>	
External	
Roof	Corrugated roof sheeting and cyclone fixings
Battens	Hardwood battens
Rafters and Purlins	Hardwood rafters
Gutters	Ogee gutter
Downpipes	Circular downpipes
Fascia's and Scotia	Hardwood fascia
Bargeboards	Hardwood bargeboards
Eaves	N/A
Soffits	N/A
Eaves Brackets	N/A
Ceiling Joists	Timber joist
Walls	Friable limestone walls
Openings	Timber window frame, double side hung timber door
Ground	Friable limestone floor random
Electrics	Security light
Others	Bluestone and cement tank stand
Internal	
Ceiling/Roof	Painted corrugated metal sheeting with timber cornice painted
Walls	Rough cement render
Openings	Timber window frame, double side hung timber door
Floors	Concrete
Fixtures and Fittings	Fluorescent light
Electrics	Switchboard and power point
Others	Brickwork fireplace
Condition	
<p>Generally, the place is in a fair condition. Areas that require attention include:</p> <ul style="list-style-type: none"> • Perform suggested maintenance works on Item 9 of CWS • Test existent mortar composition and investigate paint scrapes • Engage a heritage structural engineer for structural report before fixing major cracks • Manually rake out all cement pointing and repair with traditional mortar • Replace bargeboards where deteriorated beyond repair, prepare and repaint • Repair major crack North-western external wall • All works to be performed accordingly to Section 11 of CWS <p><i>Note: Please refer to Conservation Works Schedule 2017</i></p>

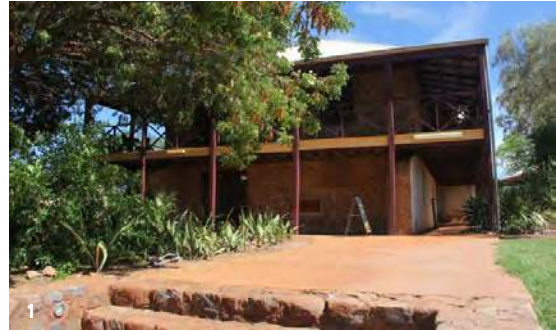
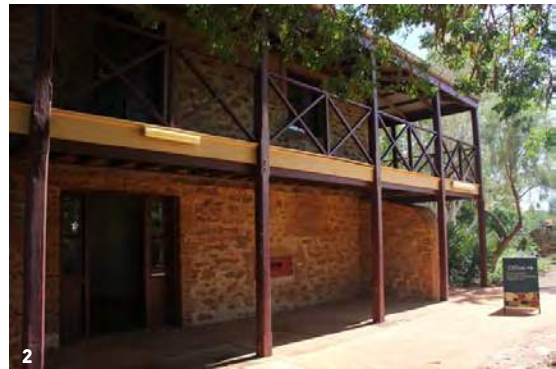
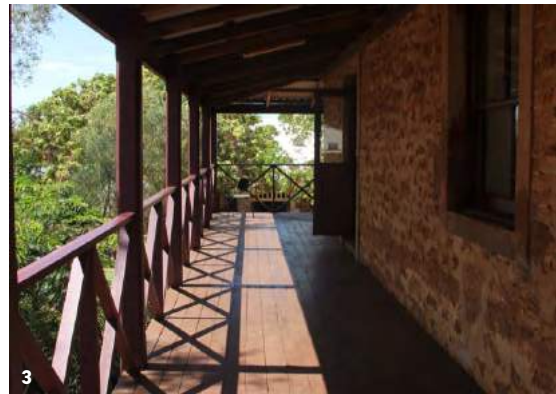
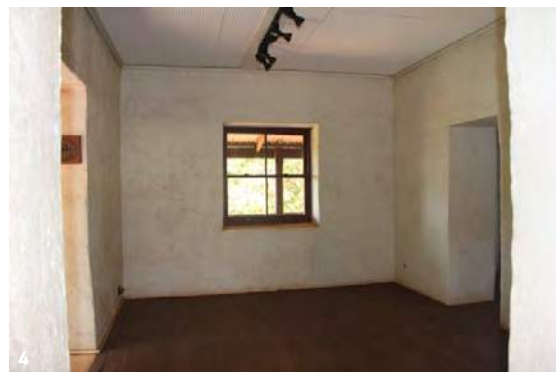
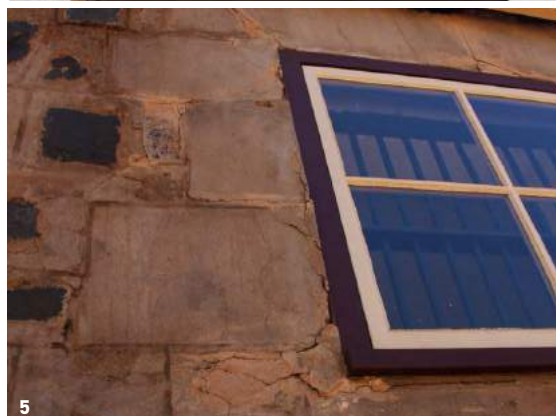
Electrics	Mini spotlights recessed to ceiling, fixtures and fittings, telephone and power sockets
Others	N/A
Condition	
<p>Generally, the place is in a fair condition. Areas that require attention include:</p> <ul style="list-style-type: none"> • Perform suggested maintenance works on Item 9 of CWS • Test existent mortar composition and investigate paint scrapes • Engage a heritage structural engineer for structural report before fixing major cracks • Manually rake out all cement pointing and repair with traditional mortar • Repair with traditional mortar base wall • Remove all redundant electrical wires • Repair major cracks • All works to be performed accordingly to Section 11 of CWS <p><i>Note: Please refer to Conservation Works Schedule 2017</i></p>	
Photographs	
<p>1 View of southeast elevation looking northwest 2 Detail of mortar composition and timber posts of south western elevation 3 Detail of timber decking composition to first floor balcony 4 Typical internal room to first floor 5 Detail of quoining and mortar composition</p>

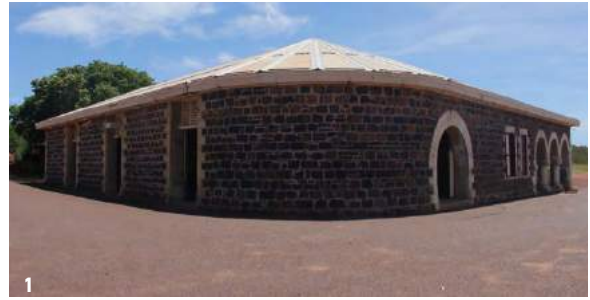
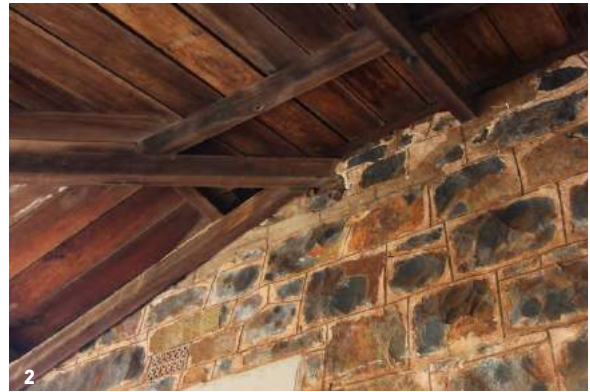
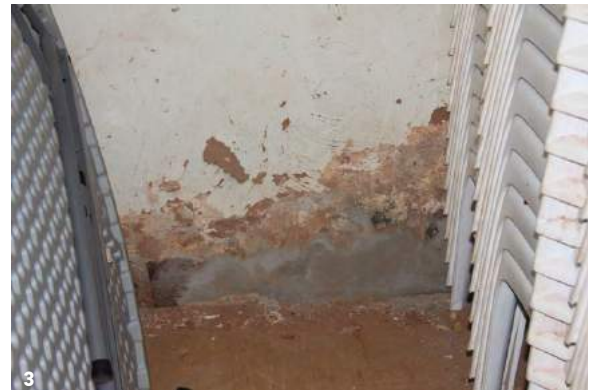
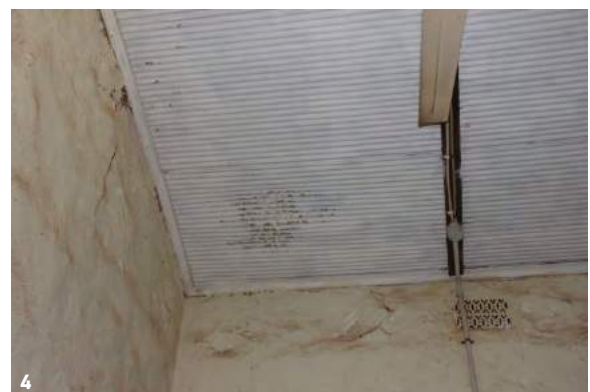
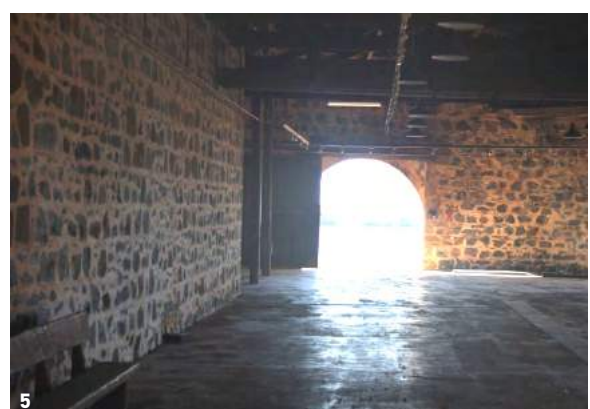
<i>Customs House and Bond Store</i>	
External	
Roof	Corrugated roof sheeting and cyclone fixings
Battens	Natural Jarrah
Rafters and Purlins	Natural Jarrah
Gutters	Valley gutter
Downpipes	N/A
Fascia's and Scotia	Jarrah painted, fixed to wall
Bargeboards	Jarrah painted, fixed to wall
Eaves	Eaves to Bonds Store
Soffits	Soffits to Bonds Store painted corrugated metal sheeting
Eaves Brackets	Painted metal
Ceiling Joists	N/A
Walls	Coursed bluestone, Repointed in lime mortar. Rendered quoining to corners. Rendered arches with quoining with pilasters. Metal balustrades
Openings	Double hung timber window and double casement timber framed shutters. Timber panelled sliding door
Ground	Red bitumen and jarrah boards with jarrah joists
Electrics	Air conditioning units and ducts. Various electrical and other telecommunications ducts
Others	Valance with corrugated metal sheets in timber frames, painted jarrah. Fluorescent lighting fittings. vent duct next to the male toilet entrance, painted

Internal	
Ceiling/Roof	Corrugated metal ceiling, painted
Walls	Coursed bluestone, original lime mortar. Rendered quoining, white tiles. Rendered plaster. Rustic limewash. Cast iron wall vent over all doors. Fireplace
Openings	Double hung timber window and double casement timber framed shutters. Timber panelled sliding door fixed louvered timber frame, double side hung door. Outer timber doors are of four panels, upper ones are black fly screen
Floors	Concrete floors
Fixtures and Fittings	Room adapted to Cafe use. Exhibition special lighting fitting. Picture railing
Electrics	Room adapted to Cafe use. General electrical wiring
Others	Gas bottles, air conditioning unit. Room adapted to cafe use
Condition	
<p>Generally, the place is in a fair condition. Areas that require attention include:</p> <ul style="list-style-type: none"> • Perform suggested maintenance works on Item 9 of CWS • Remove all redundant electrical wires • Test existent mortar composition • Manually rake out all cement pointing and repair with traditional mortar • Repair all metal ceilings, paint finish • Repair 01 door to room 5, 02 doors to Cafe • Repair all bargeboards, eaves and so its • Repair roof sheetings • Once defined use, repair cafe installations • Run new underground power supply, internal conduit vertical drops from ceiling, use galvanised metal conduit and industrial GPO's/switches. GPO's to be surface mounted galvanised boxes and face panels. All metal fittings to be earthed to code • Paint scrapes investigation to quoining, depending on existing integrity of cement render consider leaving it natural, otherwise paint with Bauwerk paint • All works to be performed accordingly to Section 11 of CWS <p>Note: Please refer to Conservation Works Schedule 2017</p>

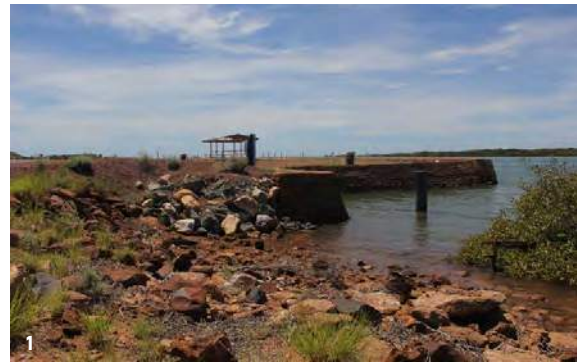
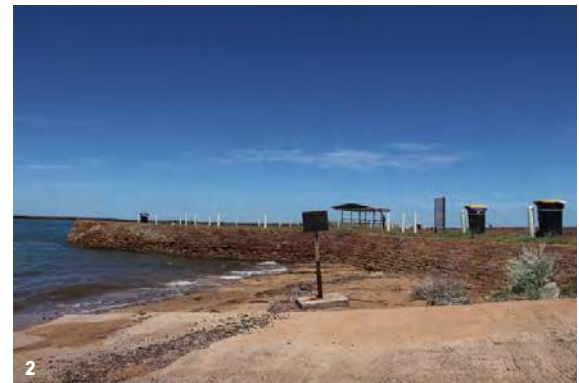
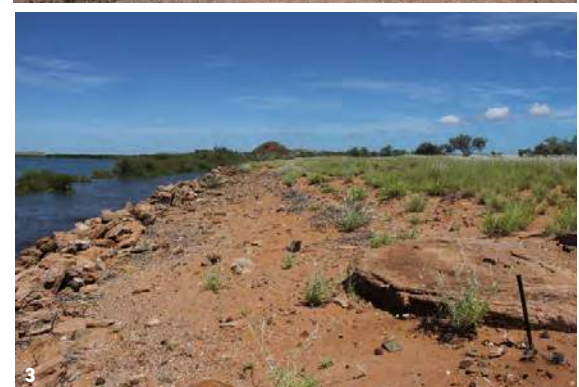
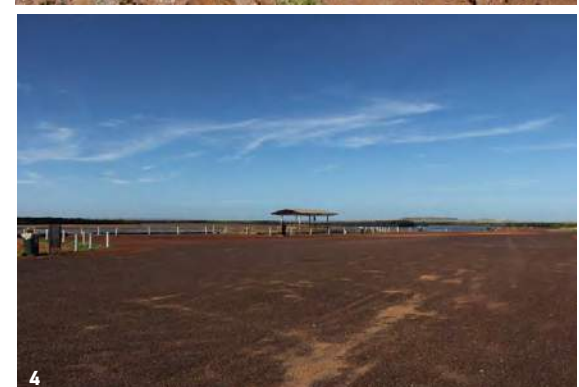
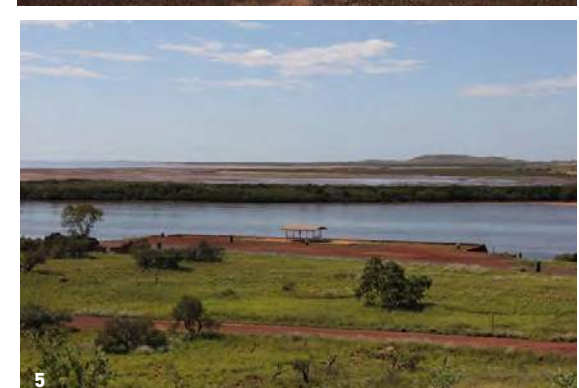
<i>Land Backed Wharf</i>	
External	
Roof Sheets and Flashing	N/A
Battens	N/A
Rafters and Purlins	N/A
Gutters	N/A
Downpipes	N/A
Fascia's and Scotia	N/A
Bargeboards	N/A
Eaves	N/A
Soffits	N/A
Eaves Brackets	N/A
Ceiling Joists	N/A
Walls	Stone and cement mortar
Openings	N/A
Ground	Gravel
Electrics	N/A
Others	N/A
Internal	
Ceiling/Roof	N/A
Walls	Stone and cement mortar
Openings	N/A
Floors	Gravel
Fixtures and Fittings	N/A
Electrics	N/A
Others	N/A
Condition	
<p>Generally, the place is in a fair condition. Areas that require attention include:</p> <ul style="list-style-type: none"> • Perform suggested maintenance works on Item 9 of CWS • Test existent mortar composition before repairs • Clean rubbish and maintain clean floors • All works to be performed accordingly to Section 11 of CWS <p>Note: Please refer to Conservation Works Schedule 2017</p>	
Photographs	
<ol style="list-style-type: none"> 1 View of northeastern side of wharf 2 View of southwestern side of wharf and boat ramp 3 Evidence of foundation 4 Car parking area to north of wharf 5 Aerial photograph of wharf looking southeast

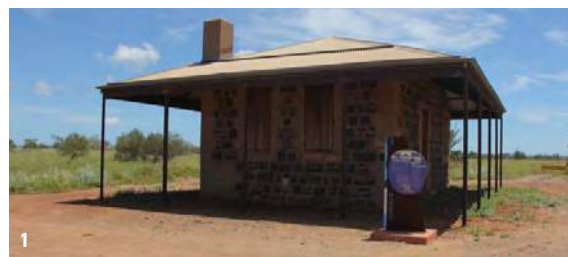
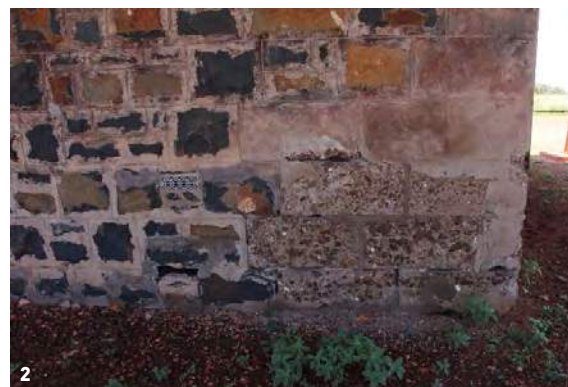
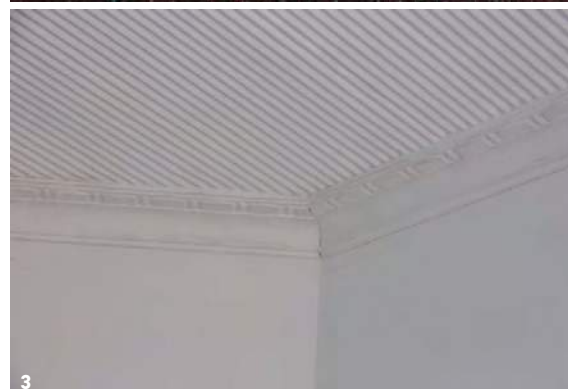
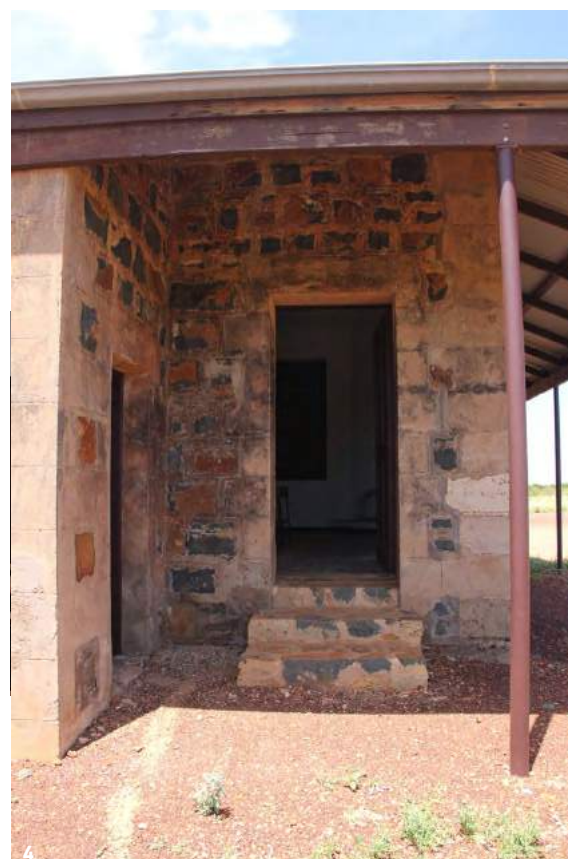
<i>Cossack School</i>	
External	
Roof	Corrugated metal roof with cyclonic fixings every fourth crest
Battens	N/A
Rafters and Purlins	Purlins connected to beam and hook over every second rafter
Gutters	Ovolo gutters with no downpipe
Downpipes	N/A
Fascia's and Scotia	Timber fascia
Bargeboards	N/A
Eaves	N/A
Soffits	N/A
Eaves Brackets	N/A
Ceiling Joists	Beam connected to post
Walls	Local bluestone, lime mortar, fretted way in parts. Quoining to corners, timber top plate subject to termite attack
Openings	Lintel over openings comprising timber pieces. Timber panel door with timber lintel
Ground	N/A
Electrics	N/A
Others	Reinstated brickface chimney with render and concrete banding. Reinstated verandah with circular verandah posts
Internal	
Ceiling/Roof	Corrugated metal roof sheeting. Scotia architrave and fixings. Boarded up skylight with timber panels
Walls	Considerable fretting to wall. Vents removed in each wall. Evidence of plastered finish to walls

Openings	Structural timber window frame remains. Opening fretted away, timber door head remains, PGI straps for door frame remain
Floors	Concrete floor
Fixtures and Fittings	N/A
Electrics	N/A
Others	Remains of fire place. No chimney remains
Condition	
<p>Generally, the place is in a fair condition. Areas that require attention include:</p> <ul style="list-style-type: none"> • Perform suggested maintenance works on Item 9 of CWS • Test existent mortar composition before repairs • Clean rubbish and maintain clean floors • All works to be performed accordingly to Section 11 of CWS <p>Note: Please refer to Conservation Works Schedule 2017</p>	
Photographs	
<p>1 View of southeast elevation looking northwest 2 Detail of mortar composition 3 Detail of ceiling damage 4 Detail of stonework to northwest elevation</p>
